Site : *1 – 2 Vulcan Close
Whitstable
Kent
CT5 4LZ*

Date : *4th August 2015*

CCTV Survey Report

Survey Ref : *TV150808*

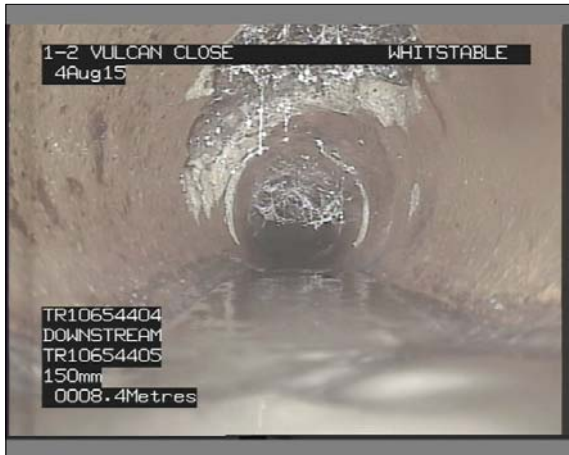
Photo: 001.JPG, VCR No.: 00002
8.4m, Hole in sewer, from 9 to 1 o'clock

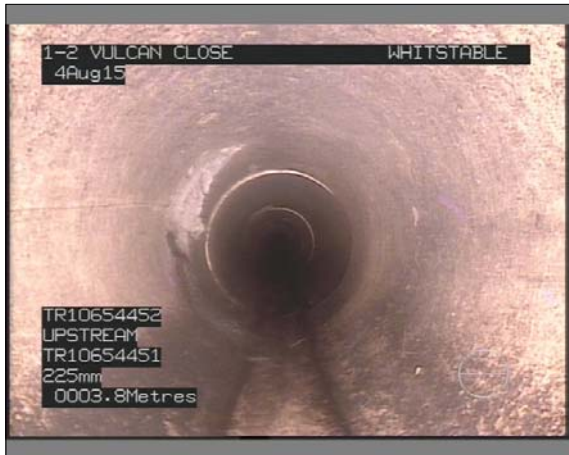
Photo: 002.JPG, VCR No.: 00003
3.8m, Crack, longitudinal, at 10 o'clock

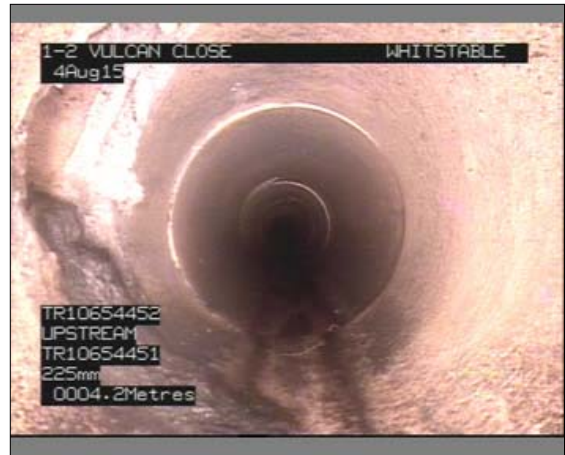
Photo: 003.jpg, VCR No.: 00003
4.3m, Connection, at 10 o'clock, 150mm diameter

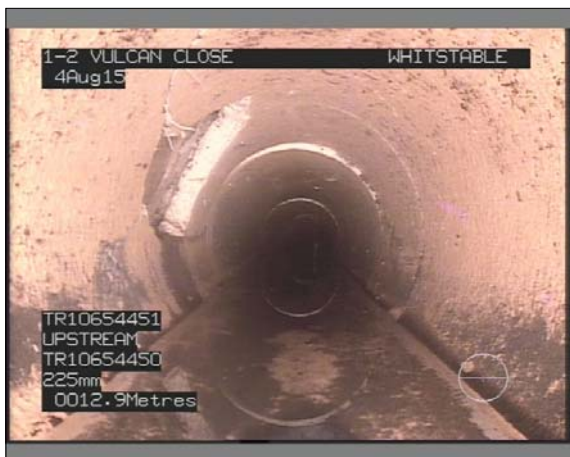
Photo: 004.JPG, VCR No.: 00004
 12.9m, Cracks, multiple, from 12 to 12 o'clock

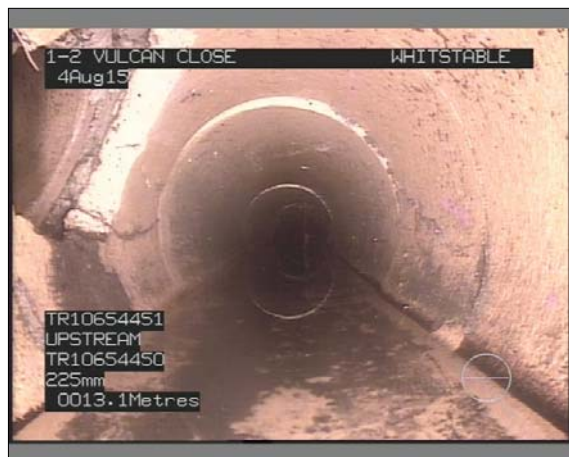
Photo: 005.JPG, VCR No.: 00004
 13.1m, Connection defective, at 10 o'clock, 150mm diameter

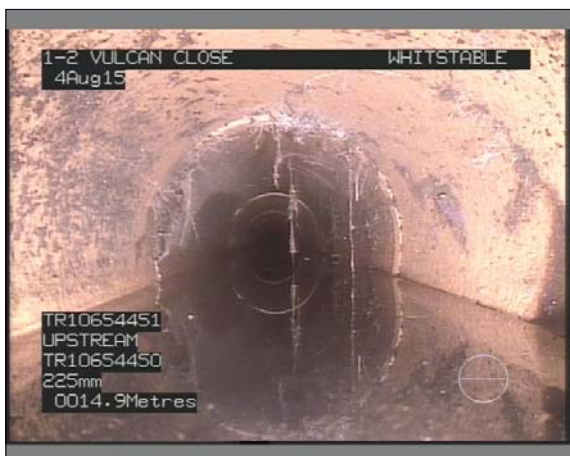
Photo: 006.JPG, VCR No.: 00004
 14.9m, Fracture, circumferential, from 12 to 4 o'clock

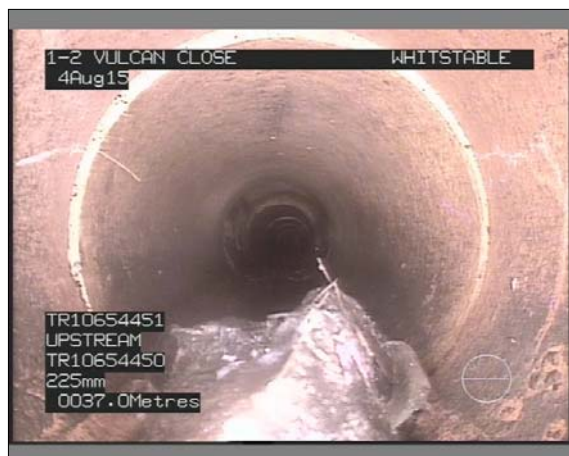
Photo: 007.JPG, VCR No.: 00004
 37m, Fracture, longitudinal at joint, at 2 o'clock

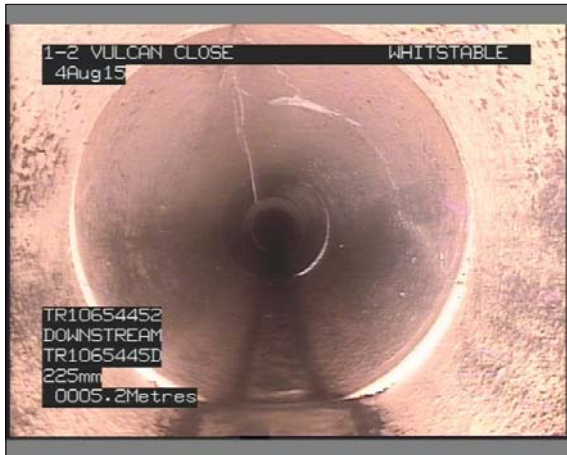
Photo: 008.JPG, VCR No.: 00005
 5.2m, Crack, circumferential at joint, from 12 to 5 o'clock

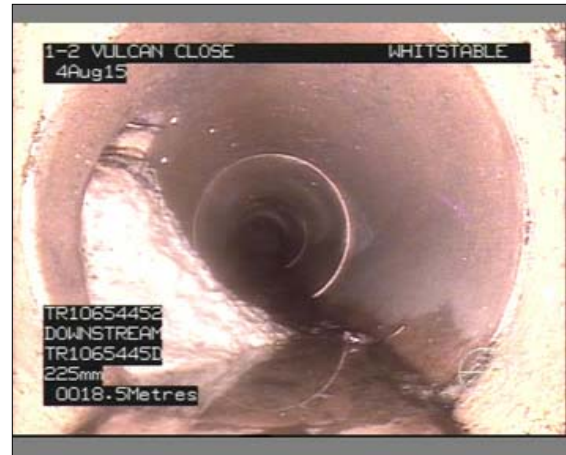
Photo: 009.jpg, VCR No.: 00005
 18.5m, Encrustation, heavy, from 6 to 10 o'clock, 25% cross-sectional area loss
