Vulcan Close, Whitstable, Kent
Phase 1 (Plots 1 to 5)

Drainage Verification Report

30 April 2024
Project Reference: 65203468
Document Reference: 66200272-SWE-XX-XX-T-C-0001-P01- Vulcan
Drainage Verification
Revision: P01
Prepared For: Aspire Designer Homes

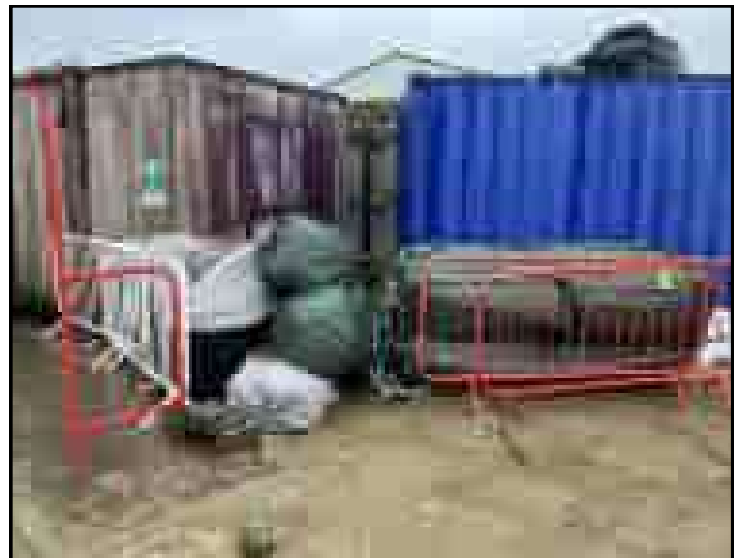
LOCATION OF FW2

FW2. UNABLE TO LOCATE / LIFT AT TIME OF SURVEY

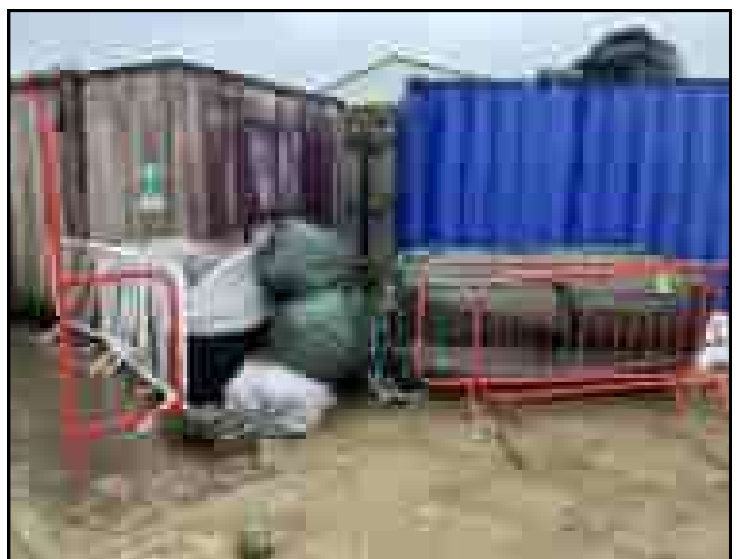
LOCATION OF SW2

SW2. UNABLE TO LOCATE / LIFT AT TIME OF SURVEY

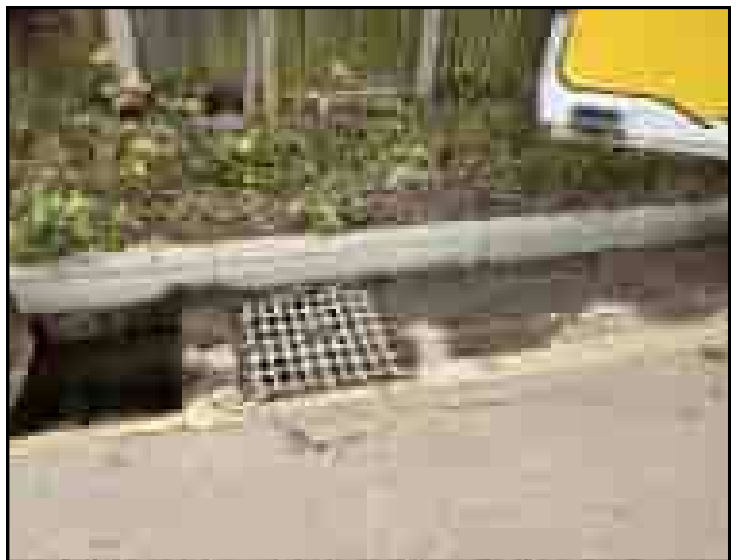
LOCATION OF GULLY 6

GULLY 6.
DEBRIS FILLED

Sweco recommend the Phase 1 drainage is jetted clean prior to first occupation, and on completion of the Phase 2 (upstream) elements.

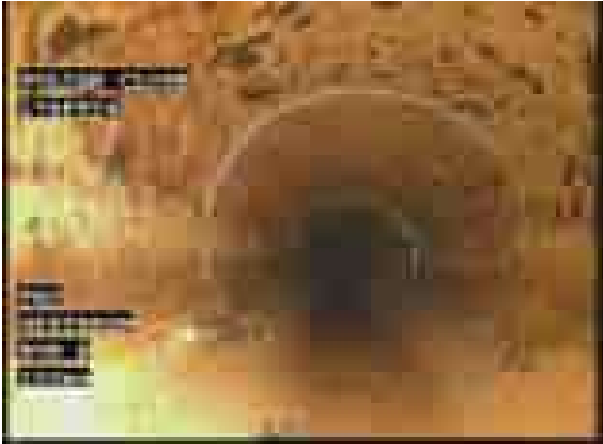
Item No.	Inspection Direction	PLR	Client's Job Ref	Contractor's Job Ref
2	Upstream	EXFWMH1X	TV240428

1, 00:00:33, 2.71 m
Crack, circumferential from 09 o'clock to 02 o'clock

Section number	Upstream manhole	Flow direction	Downstream manhole	Recommendations
1	FW2	Upstream	FW1	
2	ExFWMH1	Upstream	FW2	Repair defect(s) by lining
3	FW1	Downstream	FW3	
4	SW2	Upstream	SW1	Repair defect(s) by lining
5	ExSWMH1	Upstream	SW2	
6	SW1	Downstream	SW3	
7	FW3	Downstream	FW4	
8	SW3	Downstream	SW4	
9	FW4	Downstream	FW5	
10	SW4	Downstream	SW5	
11	RE1	Upstream	SW5	Clean by van pack jetting unit and resurvey
12	SW5	Downstream	SW6	
13	FW5	Downstream	FW6	Clean by van pack jetting unit and resurvey
14	SW6-A	Upstream	SW6	
15	SW6	Downstream	SW7	
16	FW6	Downstream	FW7	
17	RE2	Upstream	SW8	
18	SW8	Downstream	RUN X	
19	FW8	Downstream	FW7	Clean by van pack jetting unit and resurvey
20	FW7	Downstream	P.S.1	
21	SW7	Downstream	SW9	Clean by HGV JetVac unit and resurvey
22	SW10	Upstream	SW9	Clean by HGV JetVac unit and resurvey
23	SW9	Downstream	P.S.2	Clean by HGV JetVac unit and resurvey
24	RE3	Upstream	SW11	
25	SW11-B	Upstream	SW11

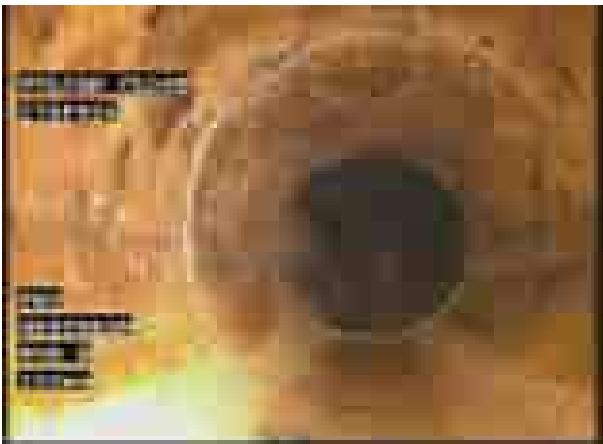
3, 00:01:09, 4.13 m
Crack, circumferential from 07 o'clock to 11 o'clock
