Project ref:TV171006

CCTV Survey Report

SITE: 17 – 20 Sea Street

Whitstable

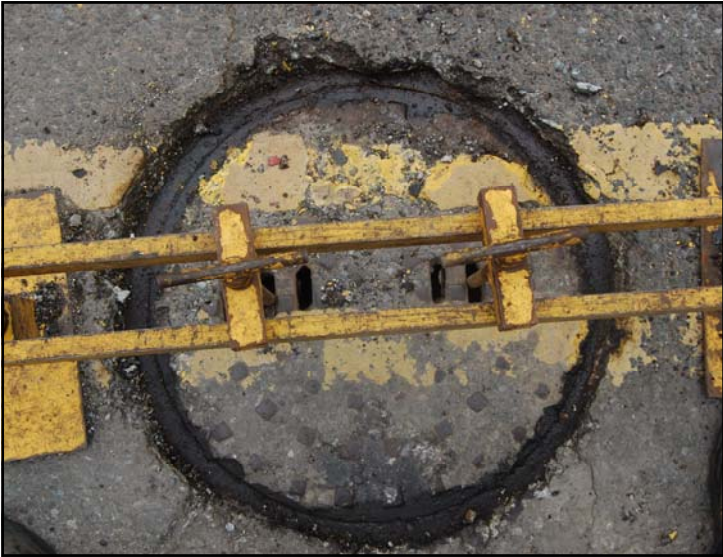
TR10666804. UNABLE TO LIFT, COVER
SIEZED IN FRAME

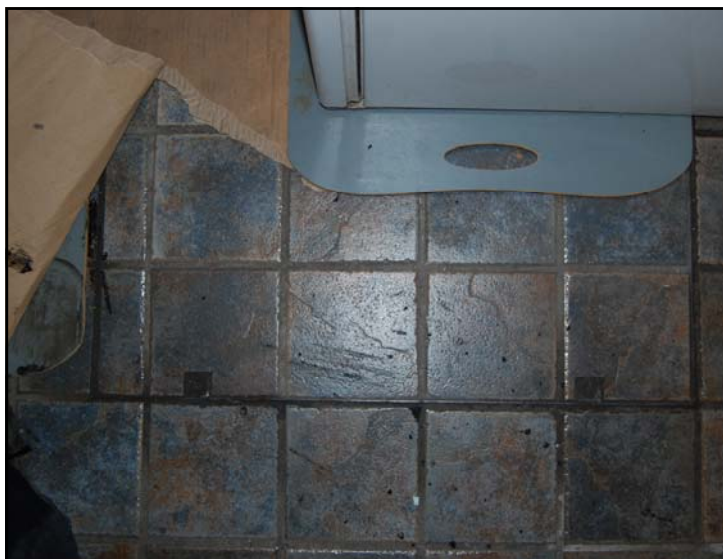
IC1 - UNABLE TO LIFT, OBSTRUCTED

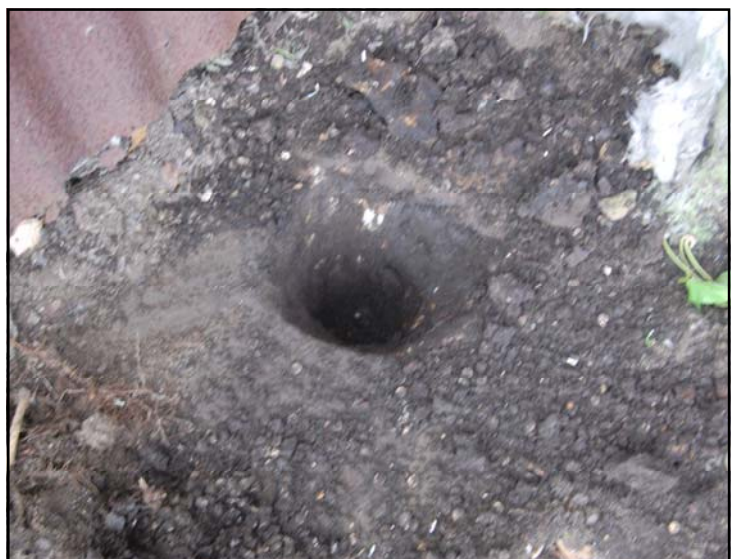
RWP 1, POSSIBLE GULLY / OUTFALL. UNABLE TO CCTV

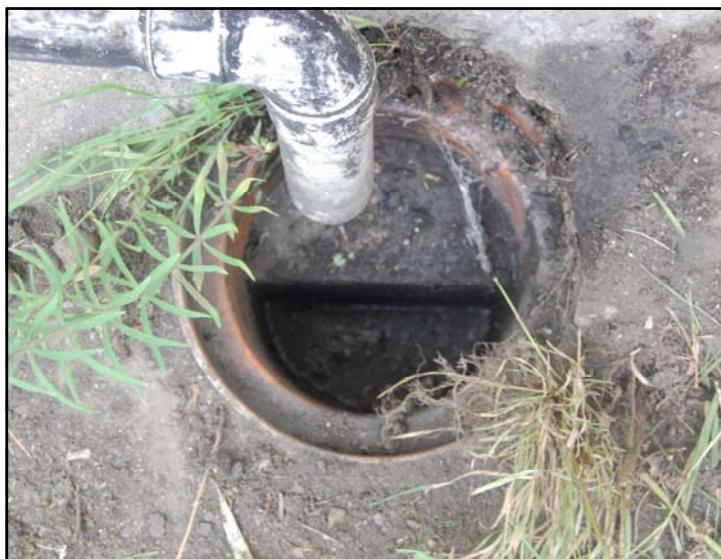
FOUL GULLY 1 - UNABLE TO CCTV

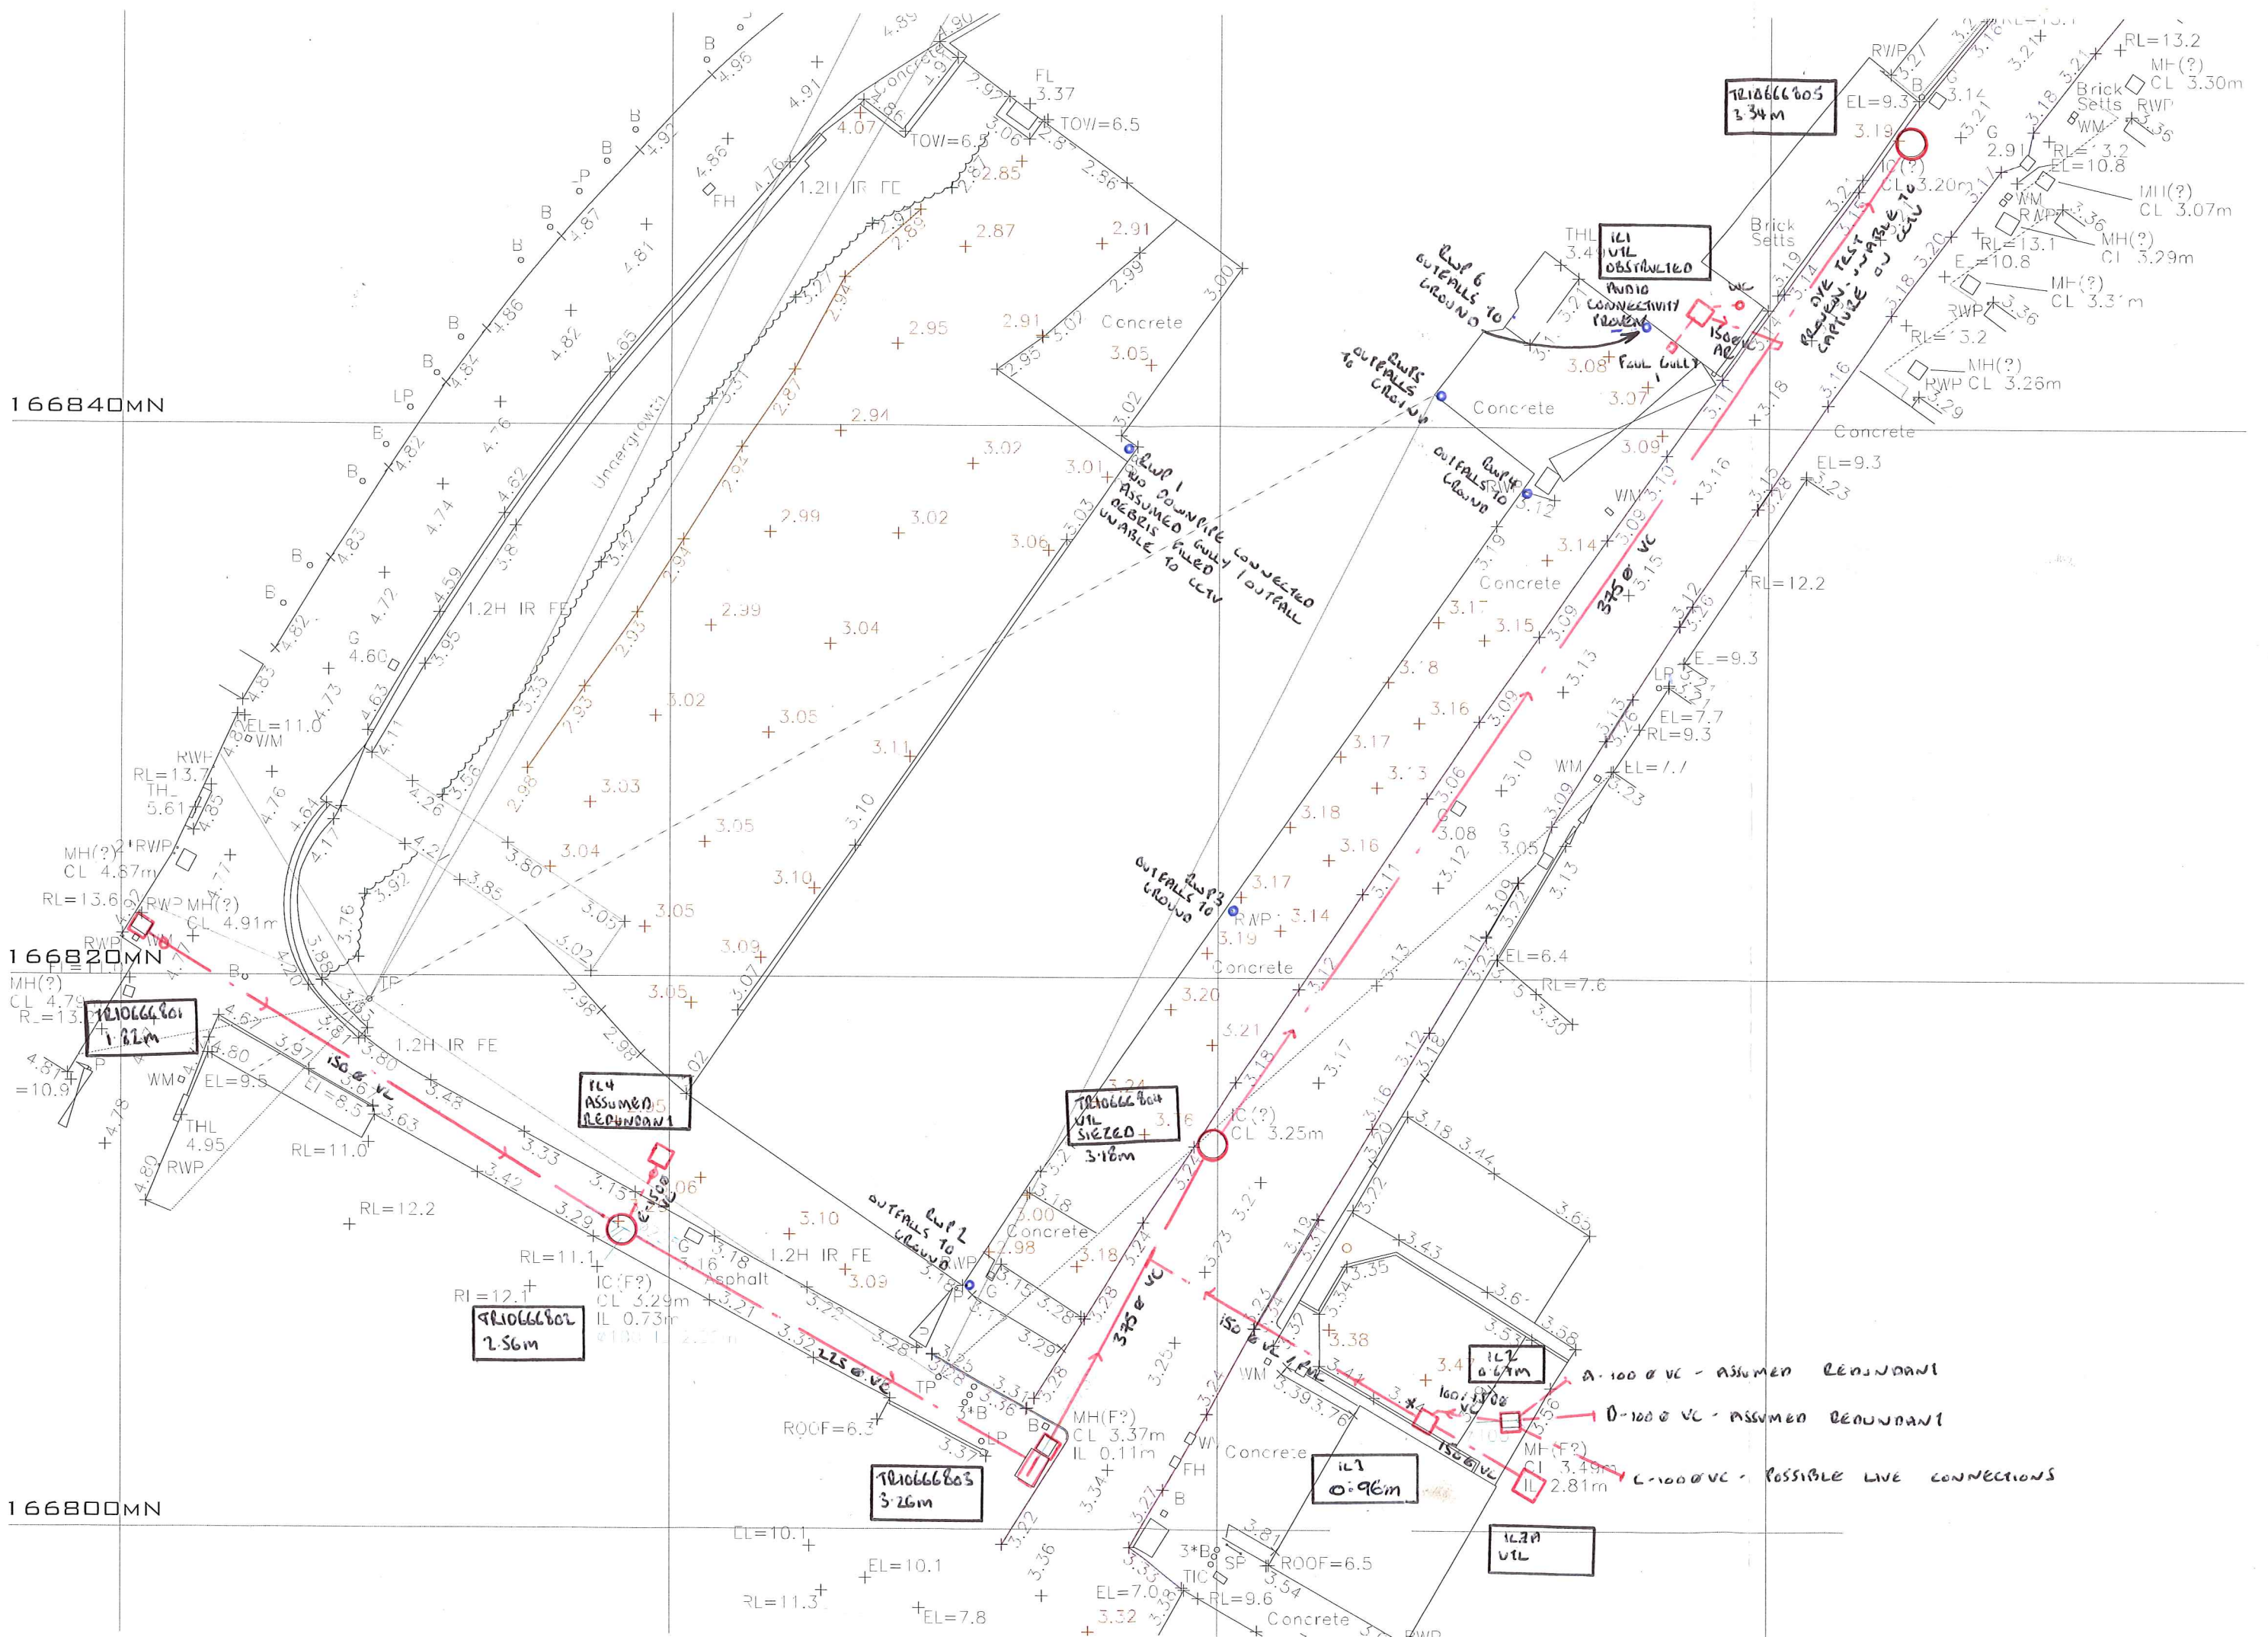
A-100 @ VC - ASSUMED REDUNDANT
 D-100 @ VC - ASSUMED REDUNDANT
 L-100 @ VC - POSSIBLE LIVE CONNECTIONS

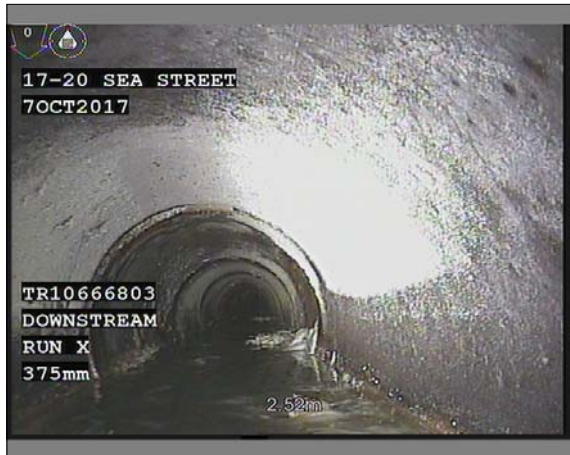
Photo: 001.JPG, VCR No.: 00001
 2.52m, Debris, 10% cross-sectional area loss, Start

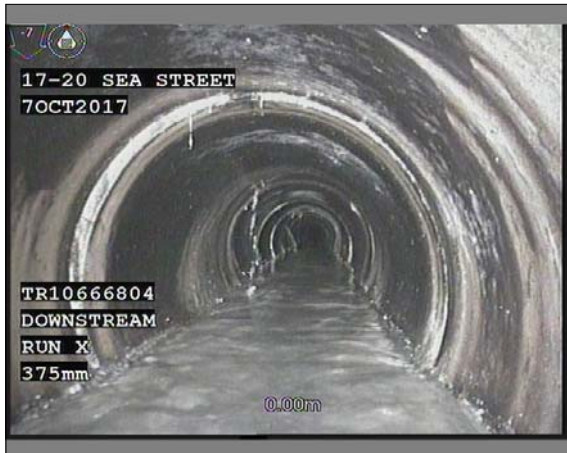
Photo: 003.JPG, VCR No.: 00002
 0m, Debris, 10% cross-sectional area loss, Start

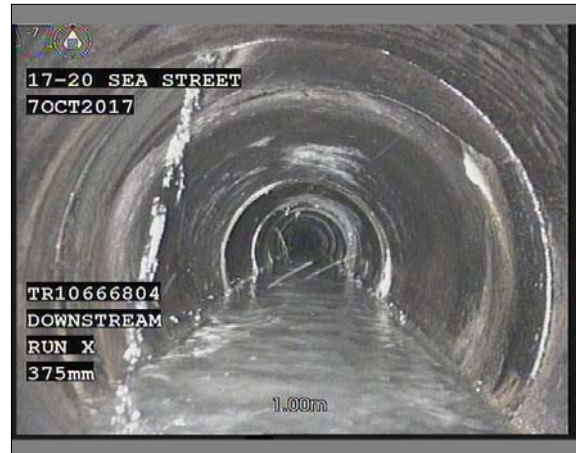
1.00	IRJ	Infiltration, runner at joint, from 10 to 11 o'clock	1 m

Photo: 004.JPG, VCR No.: 00002
 1m, Infiltration, runner at joint, from 10 to 11 o'clock

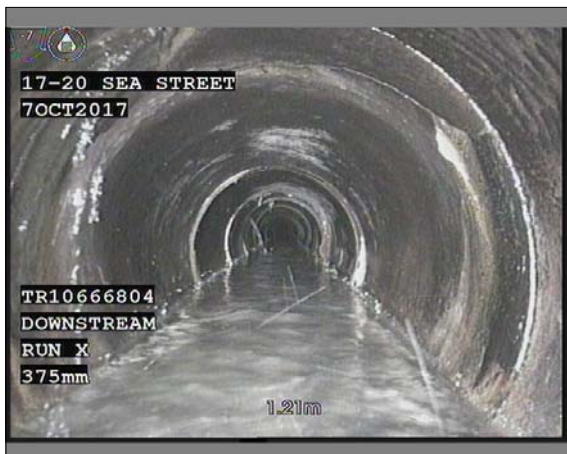
Photo: 005.JPG, VCR No.: 00002
 1.21m, Fracture, circumferential at joint, from 12 to 2 o'clock

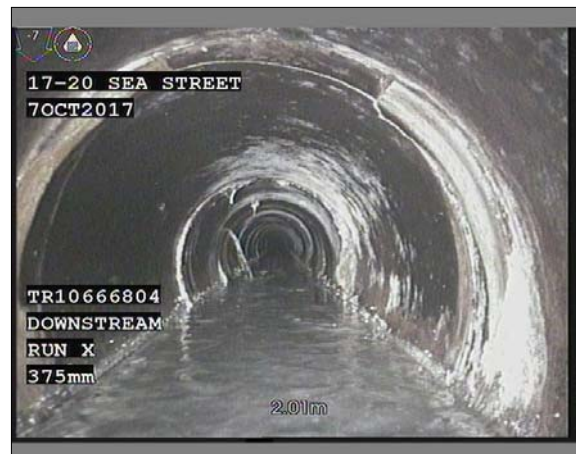
Photo: 006.JPG, VCR No.: 00002
 2.01m, Crack, circumferential at joint, from 8 to 2 o'clock

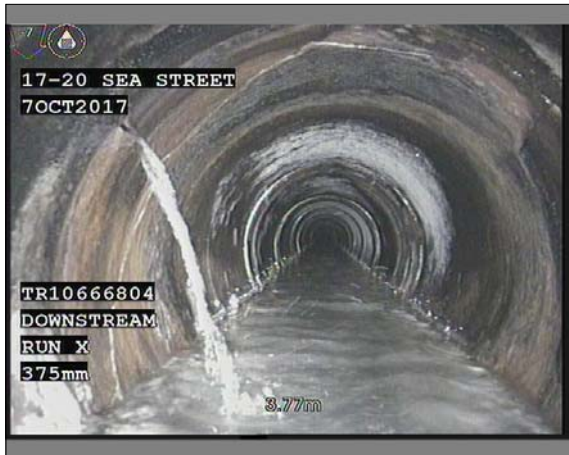
3.77	CLJ	Crack, longitudinal at joint, at 10 o'clock	1.21 m

Photo: 007.JPG, VCR No.: 00002
 3.77m, Crack, longitudinal at joint, at 10 o'clock

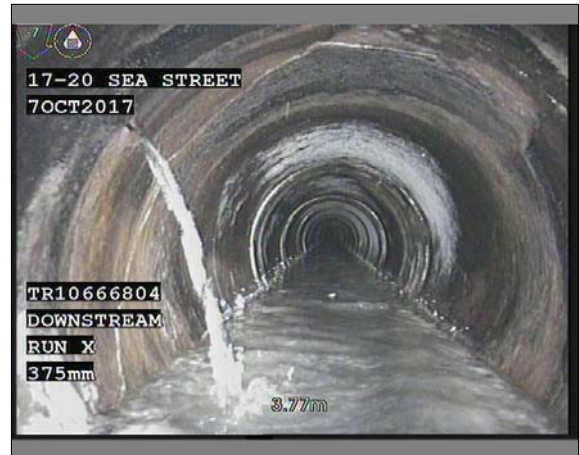
Photo: 008.JPG, VCR No.: 00002
 3.77m, Infiltration, runner at joint, from 10 to 11 o'clock

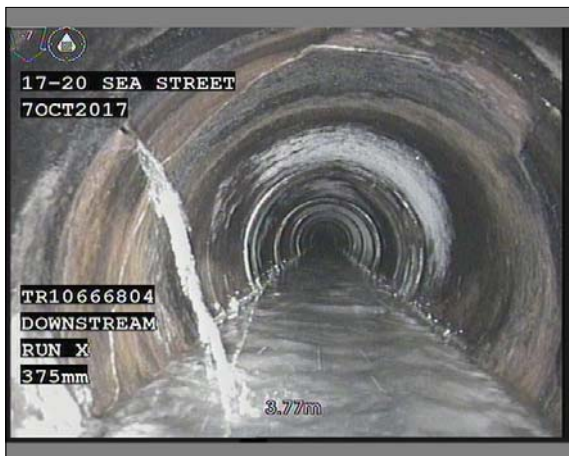
Photo: 009.JPG, VCR No.: 00002
 3.77m, Fracture, circumferential at joint, from 8 to 2 o'clock

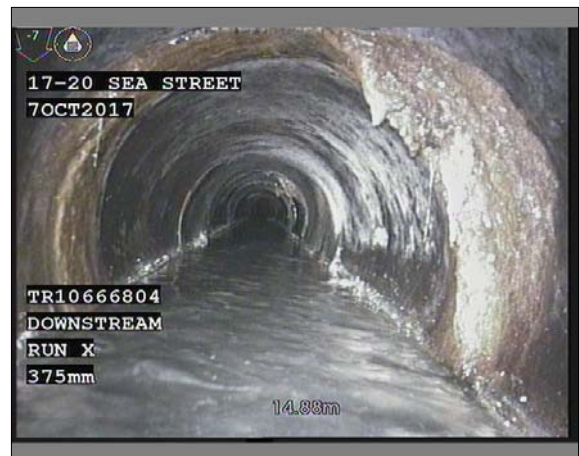
14.88	EMJ	Encrustation, medium at joint, from 12 to 4 o'clock, 10% cross-sectional area loss	2.01 m

Photo: 010.JPG, VCR No.: 00002
 14.88m, Encrustation, medium at joint, from 12 to 4 o'clock,
 10% cross-sectional area loss

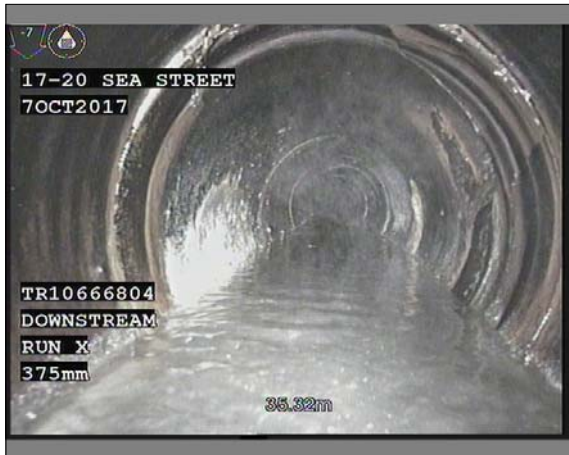
Photo: 011.JPG, VCR No.: 00002
35.32m, Infiltration, dripper at joint, from 10 to 9 o'clock

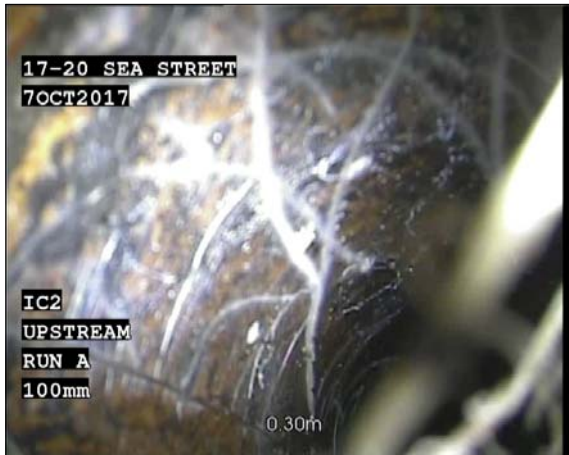
Photo: 012.jpg, VCR No.: 00003
0.3m, Roots, fine, Start

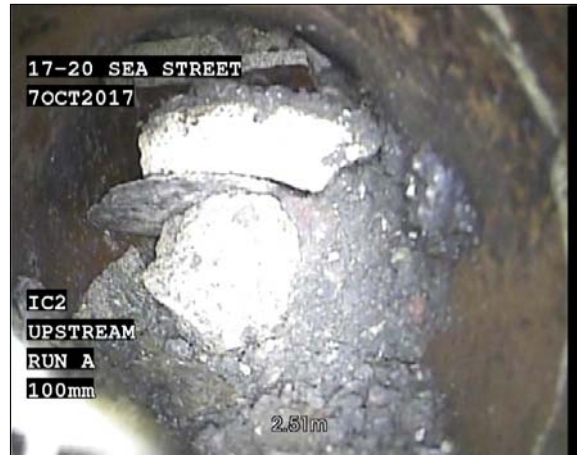
Photo: 013.jpg, VCR No.: 00003
2.51m, Debris, 95% cross-sectional area loss

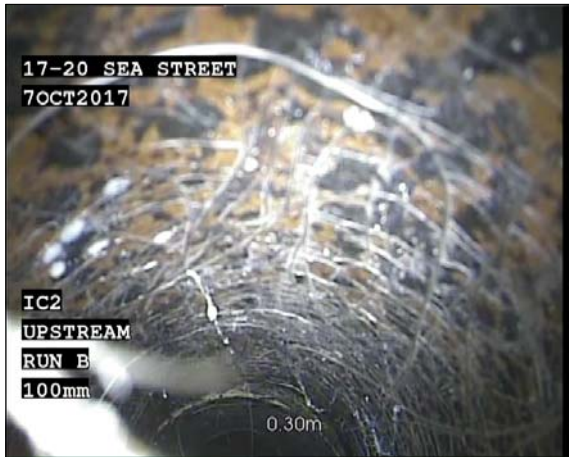
Photo: 014.jpg, VCR No.: 00004
0.3m, Roots, fine, Start

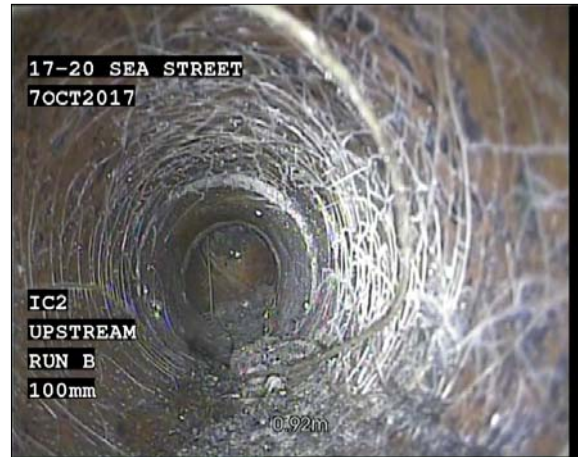
Photo: 015.jpg, VCR No.: 00004
0.92m, Debris, 5% cross-sectional area loss, Start

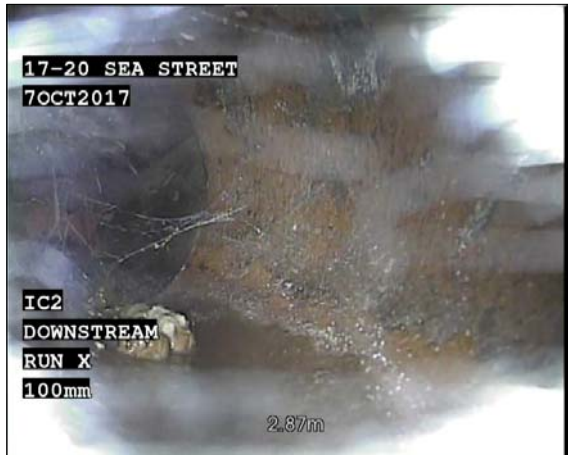
Photo: 017.jpg, VCR No.: 00006
2.87m, Debris, 5% cross-sectional area loss, Start

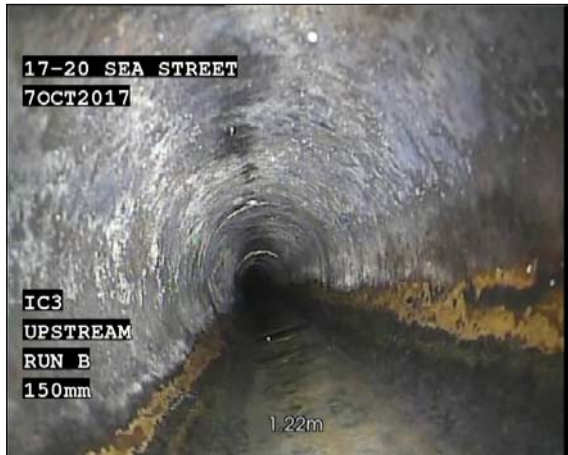
Photo: 018.jpg, VCR No.: 00007
 1.22m, Encrustation, light, from 4 to 8 o'clock, Start

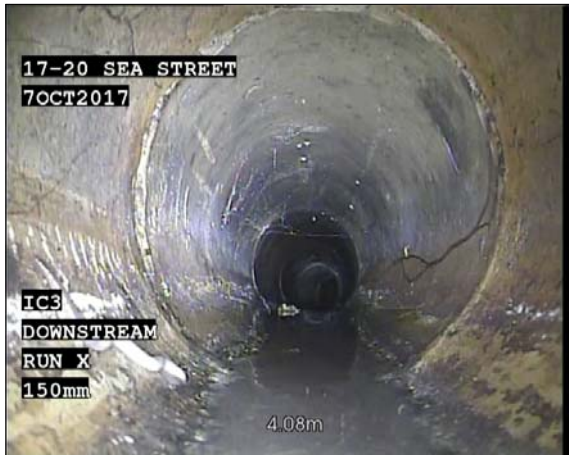
Photo: 020.jpg, VCR No.: 00008
4.08m, Roots, fine at joint

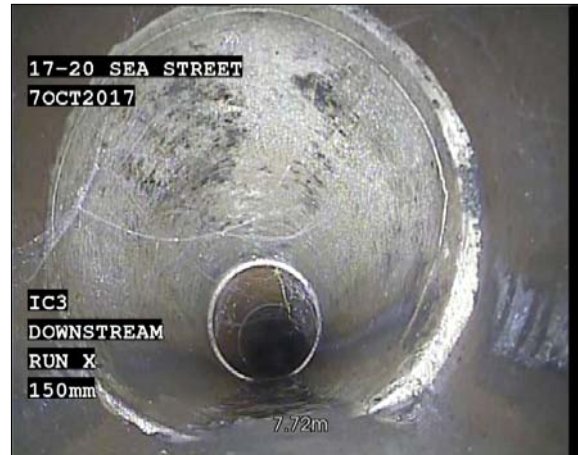
Photo: 021.jpg, VCR No.: 00008
7.72m, Crack, circumferential at joint, from 9 to 3 o'clock

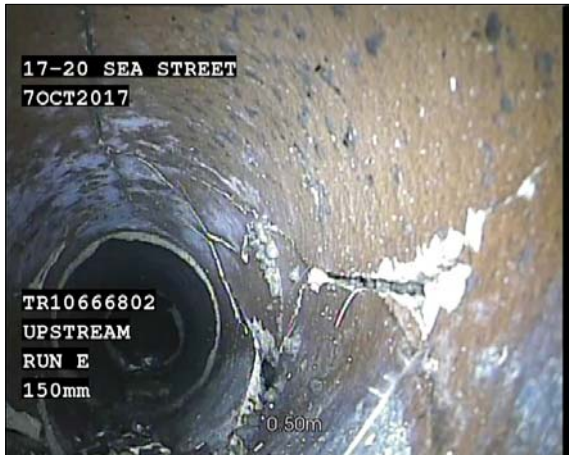
Photo: 022.jpg, VCR No.: 00009
 0.5m, Crack, longitudinal, at 3 o'clock

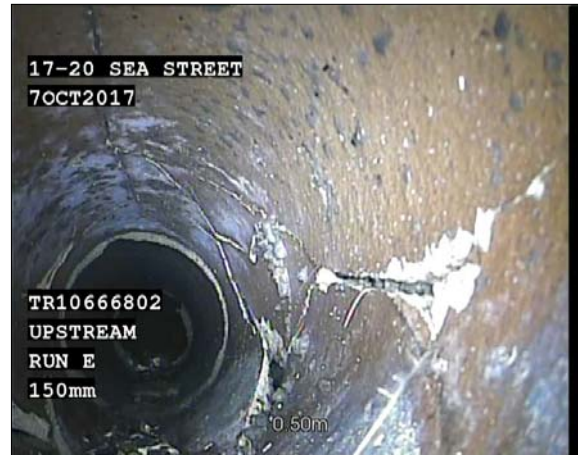
Photo: 023.jpg, VCR No.: 00009
 0.5m, Hole in sewer, from 3 to 4 o'clock

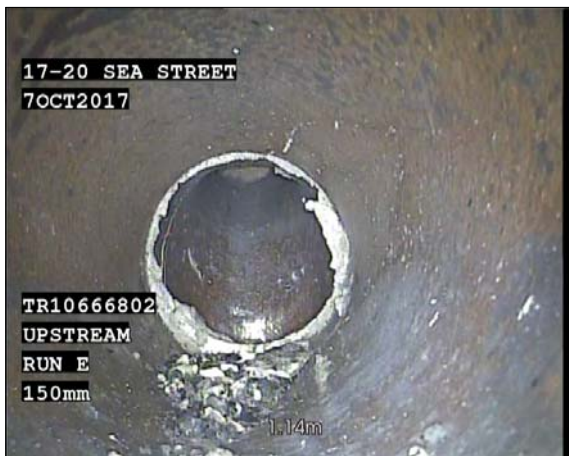
Photo: 024.jpg, VCR No.: 00009
 1.14m, Debris, 5% cross-sectional area loss, Start

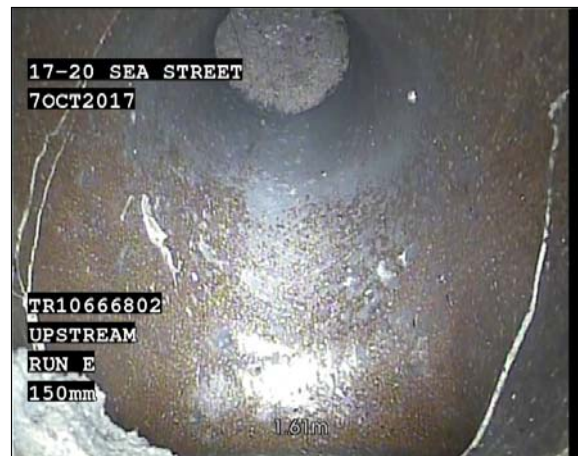
Photo: 025.jpg, VCR No.: 00009
 1.61m, Crack, circumferential, from 3 to 10 o'clock
