**ASBESTOS RE-INSPECTION REPORT
FOR ASBESTOS MATERIALS AT:**

Kings Hall
Beacon Hill, Herne Bay, Kent
CT6 6BA

Canterbury City Council
Military Road
Canterbury, Kent
CT1 1YW

PROJECT MANAGER:	JAMES PULLEN
ISSUE DATE:	11 Mar 2025
JOB NUMBER:	J034987
PROJECT REFERENCE:	FW-040
UPRN REFERENCE:	N/A
VERSION NUMBER:	V1
REVISION NUMBER:	002
PAGE NUMBER:	1 OF 52

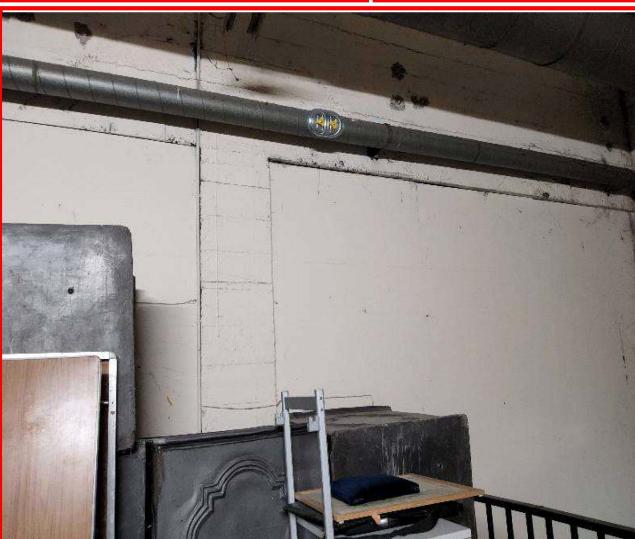
FINDING REFERENCE:	1	LOCATION, DESCRIPTION & EXTENT

BUILDING:	Main Building	
	FLOOR:	1st Floor	
	AREA:	Above Dressing Rooms Area	
	LOCATION:	To Walls (Over Stage Entrance Doors)	
	DESCRIPTION:	Insulating Board Panels	
	EXTENT:	18m ²	
	ACCESSIBILITY:	Easily disturbed

MATERIAL ASSESSMENT (MA)			SAMPLE INFORMATION	
MC:	Good Condition	0	LEVEL OF IDENTIFICATION:	Sampled + Analysed
ST:	Surface Sealed / Enclosed Lagging & Sprays	1	SAMPLE REFERENCE:	NR007601*
PT:	Insulating Board	2	ASBESTOS TYPE 1 (AT):	Amosite
ASBESTOS TYPE (AT) SCORE:	2	2	ASBESTOS TYPE 2 (AT):	Chrysotile
ALGORITHM SCORE:	5	5	ASBESTOS TYPE 3 (AT):	N/A
RISK LEVEL:	Low	Low	MATERIAL CLASSIFICATION:	Insulating Board

RECOMMENDATION:	Encapsulate & Manage
SURVEYORS COMMENT:	Continue to manage and monitor item in situ.

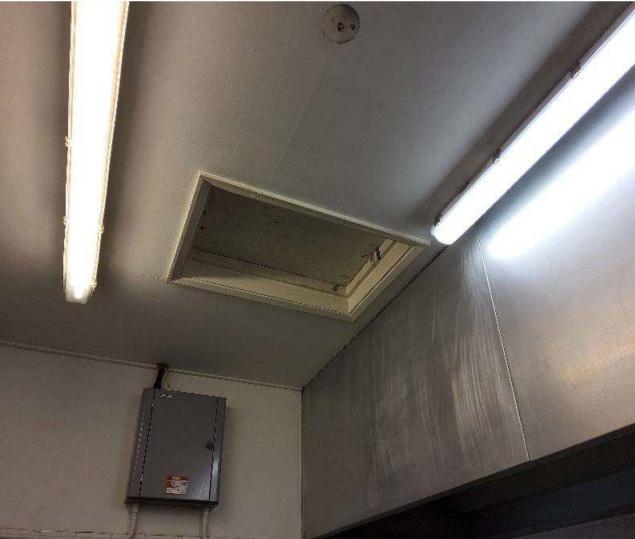
FINDING REFERENCE:	2	LOCATION, DESCRIPTION & EXTENT

BUILDING:	Main Building
		FLOOR:	Ground Floor
		AREA:	Cafe Kitchen
		LOCATION:	Loose in Ceiling Void (Above Cookers)
		DESCRIPTION:	Cement Panel
		EXTENT:	0.25m ²
		ACCESSIBILITY:	Usually inaccessible or unlikely to be disturbed

MATERIAL ASSESSMENT (MA)			SAMPLE INFORMATION	
MC:	Low Damage	1	LEVEL OF IDENTIFICATION:	Presumed
ST:	Surface Sealed / Enclosed Lagging & Sprays	1	SAMPLE REFERENCE:	Visual
PT:	Cement	1	ASBESTOS TYPE 1 (AT):	Chrysotile
ASBESTOS TYPE (AT) SCORE:		1	ASBESTOS TYPE 2 (AT):	N/A
ALGORITHM SCORE:	4		ASBESTOS TYPE 3 (AT):	N/A
RISK LEVEL:	Very Low		MATERIAL CLASSIFICATION:	Cement

RECOMMENDATION:	Manage & Monitor Condition
SURVEYORS COMMENT:	Previously Presumed Chrysotile. Unable to access due to kitchen equipment blocking access. Item previously identified in on-site Asbestos Register. Continue to manage and monitor item in situ.

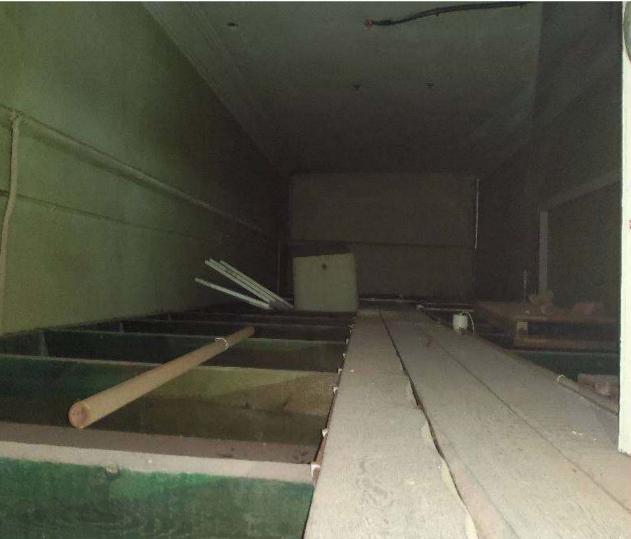
FINDING REFERENCE:	3	LOCATION, DESCRIPTION & EXTENT

BUILDING:	Main Building
		FLOOR:	Ground Floor
		AREA:	Cafe Kitchen
		LOCATION:	Within Ceiling Void (Over Wash Up Area)
		DESCRIPTION:	Cement Water Tank
		EXTENT:	1no.
		ACCESSIBILITY:	Usually inaccessible or unlikely to be disturbed

MATERIAL ASSESSMENT (MA)			SAMPLE INFORMATION	
MC:	Good Condition	0	LEVEL OF IDENTIFICATION:	Presumed
ST:	Surface Sealed / Enclosed Lagging & Sprays	1	SAMPLE REFERENCE:	Visual
PT:	Cement	1	ASBESTOS TYPE 1 (AT):	Chrysotile
ASBESTOS TYPE (AT) SCORE:		1	ASBESTOS TYPE 2 (AT):	N/A
ALGORITHM SCORE:	3		ASBESTOS TYPE 3 (AT):	N/A
RISK LEVEL:	Very Low		MATERIAL CLASSIFICATION:	Cement

RECOMMENDATION:	Manage & Monitor Condition
SURVEYORS COMMENT:	Previously Presumed Chrysotile. Unable to access due to kitchen equipment blocking access Item previously identified in on-site Asbestos Register. Continue to manage and monitor item in situ.

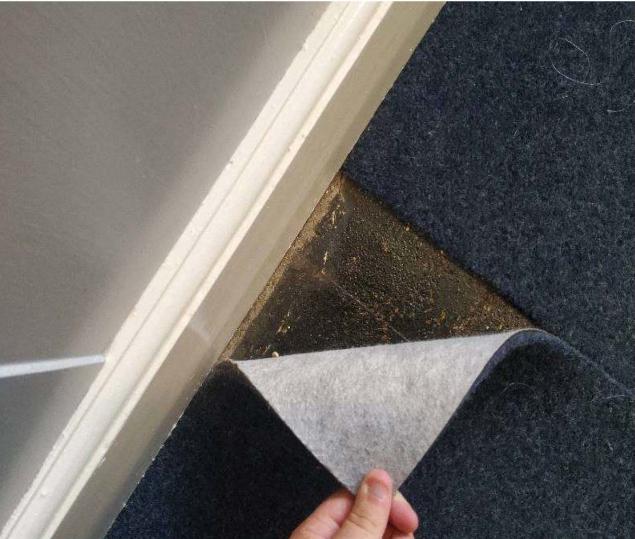
FINDING REFERENCE:	5	LOCATION, DESCRIPTION & EXTENT

BUILDING:	Main Building
		FLOOR:	2nd Floor
		AREA:	Stairwell
		LOCATION:	To Concrete Floor (Below Carpet Tiles)
		DESCRIPTION:	Bitumen Adhesive
		EXTENT:	6m ²
		ACCESSIBILITY:	Occasionally likely to be disturbed

MATERIAL ASSESSMENT (MA)			SAMPLE INFORMATION	
MC:	Low Damage	1	LEVEL OF IDENTIFICATION:	Sampled + Analysed
ST:	Composite Material	0	SAMPLE REFERENCE:	NR007602*
PT:	Bitumen Products	1	ASBESTOS TYPE 1 (AT):	Chrysotile
ASBESTOS TYPE (AT) SCORE:	1	1	ASBESTOS TYPE 2 (AT):	N/A
ALGORITHM SCORE:	3	3	ASBESTOS TYPE 3 (AT):	N/A
RISK LEVEL:	Very Low		MATERIAL CLASSIFICATION:	Bitumen Products

RECOMMENDATION:	Manage & Monitor Condition
SURVEYORS COMMENT:	Continue to manage and monitor item in situ.

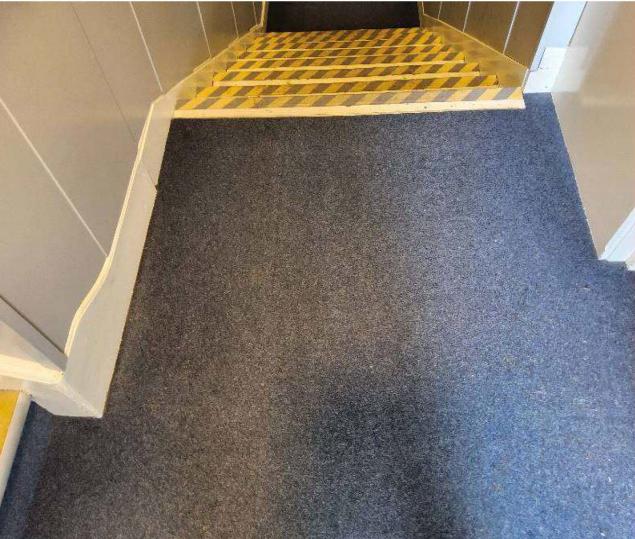
FINDING REFERENCE:	6	LOCATION, DESCRIPTION & EXTENT

BUILDING:	Main Building
		FLOOR:	1st Floor
		AREA:	Landing
		LOCATION:	To Concrete Floor (Below Carpet Tiles)
		DESCRIPTION:	Floor Tiles and Bitumen Adhesive
		EXTENT:	3m ²
		ACCESSIBILITY:	Occasionally likely to be disturbed

MATERIAL ASSESSMENT (MA)			SAMPLE INFORMATION	
MC:	Good Condition	0	LEVEL OF IDENTIFICATION:	Sampled + Analysed
ST:	Composite Material	0	SAMPLE REFERENCE:	NR007603*
PT:	Floor Tiles & Bitumen Adhesive	1	ASBESTOS TYPE 1 (AT):	Chrysotile
ASBESTOS TYPE (AT) SCORE:		1	ASBESTOS TYPE 2 (AT):	N/A
ALGORITHM SCORE:		2	ASBESTOS TYPE 3 (AT):	N/A
RISK LEVEL:	Very Low		MATERIAL CLASSIFICATION:	Floor Tiles & Bitumen Adhesive

RECOMMENDATION:	Manage & Monitor Condition
SURVEYORS COMMENT:	Continue to manage and monitor item in situ.

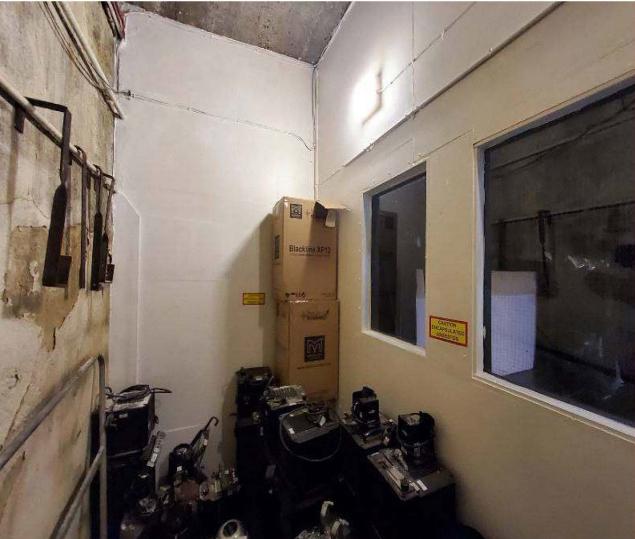
FINDING REFERENCE:	8	LOCATION, DESCRIPTION & EXTENT	
		BUILDING:	Main Building
		FLOOR:	Ground Floor
		AREA:	Stage
		LOCATION:	To Inside Walls of Stage Electric Room
		DESCRIPTION:	Insulating Board Panels
		EXTENT:	20m ²
		ACCESSIBILITY:	Easily disturbed

MATERIAL ASSESSMENT (MA)			SAMPLE INFORMATION	
MC:	Good Condition	0	LEVEL OF IDENTIFICATION:	Presumed
ST:	Surface Sealed / Enclosed Lagging & Sprays	1	SAMPLE REFERENCE:	Visual
PT:	Insulating Board	2	ASBESTOS TYPE 1 (AT):	Amosite
ASBESTOS TYPE (AT) SCORE:	2	2	ASBESTOS TYPE 2 (AT):	N/A
ALGORITHM SCORE:	5	5	ASBESTOS TYPE 3 (AT):	N/A
RISK LEVEL:	Low	Low	MATERIAL CLASSIFICATION:	Insulating Board

RECOMMENDATION:	Manage & Monitor Condition
SURVEYORS COMMENT:	Previously Presumed Amosite. Item previously identified within on-site Asbestos Register. No sample obtained so not to disturb encapsulation. Continue to manage and monitor item in situ.

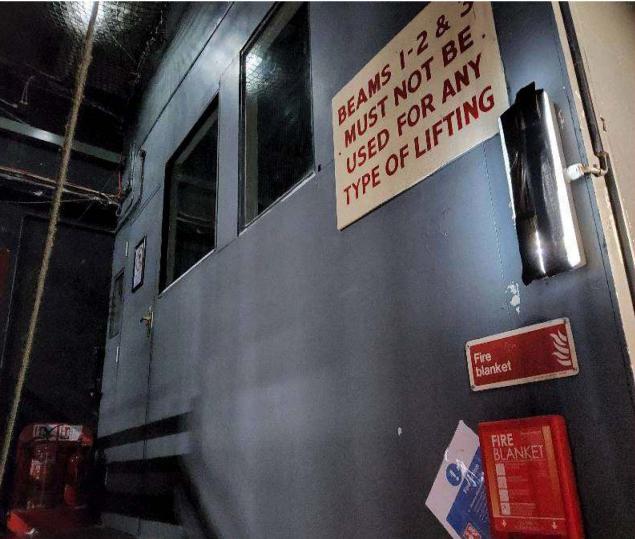
FINDING REFERENCE:	9	LOCATION, DESCRIPTION & EXTENT

BUILDING:	Main Building
		FLOOR:	Ground Floor
		AREA:	Stage
		LOCATION:	To Outside Walls of Stage Electrical Room
		DESCRIPTION:	Insulating Board Panels
		EXTENT:	20m ²
		ACCESSIBILITY:	Easily disturbed

MATERIAL ASSESSMENT (MA)			SAMPLE INFORMATION	
MC:	Good Condition	0	LEVEL OF IDENTIFICATION:	Presumed
ST:	Surface Sealed / Enclosed Lagging & Sprays	1	SAMPLE REFERENCE:	Visual
PT:	Insulating Board	2	ASBESTOS TYPE 1 (AT):	Amosite
ASBESTOS TYPE (AT) SCORE:	2	2	ASBESTOS TYPE 2 (AT):	N/A
ALGORITHM SCORE:	5	5	ASBESTOS TYPE 3 (AT):	N/A
RISK LEVEL:	Low	Low	MATERIAL CLASSIFICATION:	Insulating Board

RECOMMENDATION:	Manage & Monitor Condition
SURVEYORS COMMENT:	Previously Presumed Amosite. Item previously identified within on-site Asbestos Register. No sample obtained so not to disturb encapsulation. Continue to manage and monitor item in situ.

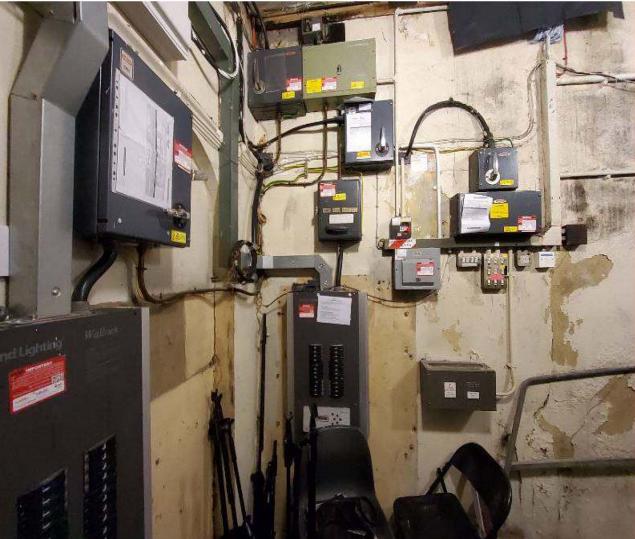
FINDING REFERENCE:		10	LOCATION, DESCRIPTION & EXTENT

BUILDING:	Main Building
			FLOOR:	Ground Floor
			AREA:	Stage
			LOCATION:	Within Electrics
			DESCRIPTION:	Textile Flash Guards
			EXTENT:	8no.
			ACCESSIBILITY:	Usually inaccessible or unlikely to be disturbed

MATERIAL ASSESSMENT (MA)			SAMPLE INFORMATION	
MC:	Good Condition	0	LEVEL OF IDENTIFICATION:	Presumed
ST:	Surface Sealed / Enclosed Lagging & Sprays	1	SAMPLE REFERENCE:	Visual
PT:	Textiles/Paper	2	ASBESTOS TYPE 1 (AT):	Chrysotile
ASBESTOS TYPE (AT) SCORE:		1	ASBESTOS TYPE 2 (AT):	N/A
ALGORITHM SCORE:		4	ASBESTOS TYPE 3 (AT):	N/A
RISK LEVEL:	Very Low		MATERIAL CLASSIFICATION:	Textiles/Paper

RECOMMENDATION:	Manage & Monitor Condition
SURVEYORS COMMENT:	Previously Presumed Chrysotile. No sample obtained due to being live during survey. Continue to manage and monitor item in situ.

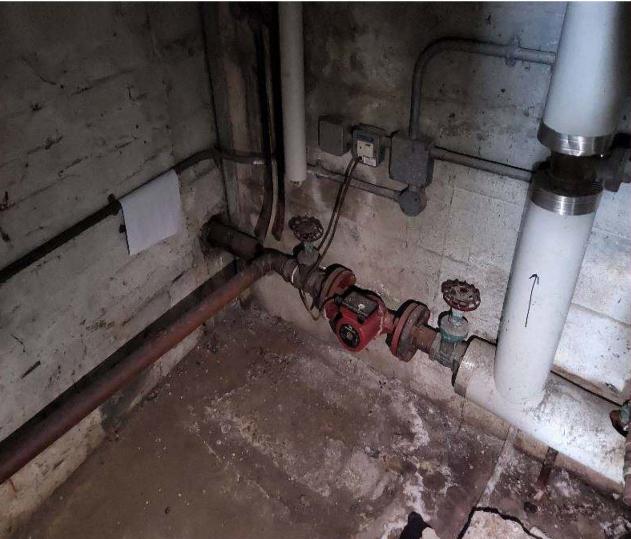
FINDING REFERENCE:	11	LOCATION, DESCRIPTION & EXTENT

BUILDING:	Main Building
		FLOOR:	External
		AREA:	Boiler Room
		LOCATION:	To Boiler Pipework
		DESCRIPTION:	Gaskets
		EXTENT:	2no.
		ACCESSIBILITY:	Usually inaccessible or unlikely to be disturbed

MATERIAL ASSESSMENT (MA)			SAMPLE INFORMATION	
MC:	Low Damage	1	LEVEL OF IDENTIFICATION:	Sampled + Analysed
ST:	Surface Sealed / Enclosed Lagging & Sprays	1	SAMPLE REFERENCE:	NR007618*
PT:	Textiles/Paper	2	ASBESTOS TYPE 1 (AT):	Chrysotile
ASBESTOS TYPE (AT) SCORE:	1	1	ASBESTOS TYPE 2 (AT):	N/A
ALGORITHM SCORE:	5	5	ASBESTOS TYPE 3 (AT):	N/A
RISK LEVEL:	Low	Low	MATERIAL CLASSIFICATION:	Textiles/Paper

RECOMMENDATION:	Manage & Monitor Condition
SURVEYORS COMMENT:	Continue to manage and monitor item in situ.

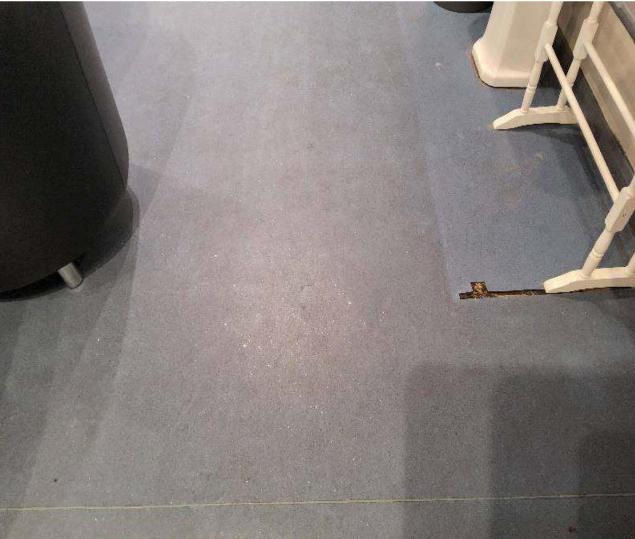
FINDING REFERENCE:	13	LOCATION, DESCRIPTION & EXTENT

BUILDING:	Main Building
		FLOOR:	Ground Floor
		AREA:	Dressing Room 1
		LOCATION:	To Concrete Floor (Below Modern Vinyl)
		DESCRIPTION:	Bitumen Adhesive
		EXTENT:	20m ²
		ACCESSIBILITY:	Occasionally likely to be disturbed

MATERIAL ASSESSMENT (MA)			SAMPLE INFORMATION	
MC:	Good Condition	0	LEVEL OF IDENTIFICATION:	Referred to a visually identical material
ST:	Composite Material	0	SAMPLE REFERENCE:	As NR007606*
PT:	Bitumen Products	1	ASBESTOS TYPE 1 (AT):	Chrysotile
ASBESTOS TYPE (AT) SCORE:		1	ASBESTOS TYPE 2 (AT):	N/A
ALGORITHM SCORE:		2	ASBESTOS TYPE 3 (AT):	N/A
RISK LEVEL:		Very Low	MATERIAL CLASSIFICATION:	Bitumen Products

RECOMMENDATION:	Manage & Monitor Condition
SURVEYORS COMMENT:	Continue to manage and monitor item in situ.

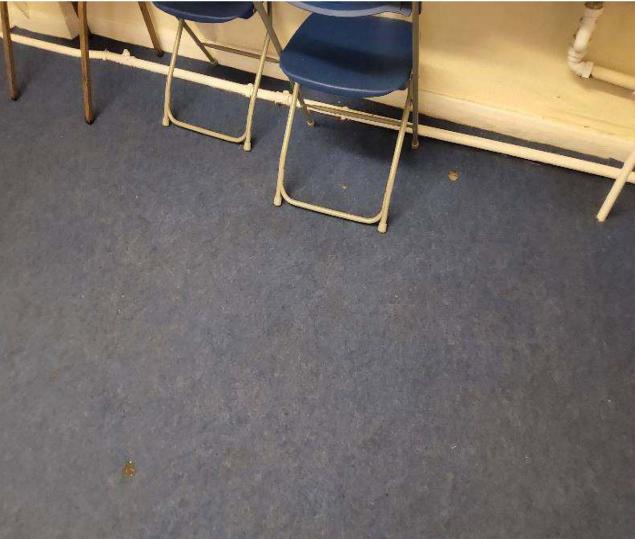
FINDING REFERENCE:	15	LOCATION, DESCRIPTION & EXTENT

BUILDING:	Main Building
		FLOOR:	Ground Floor
		AREA:	Dressing Room 3
		LOCATION:	To Concrete Floor (Below Carpet Tiles)
		DESCRIPTION:	Floor Tiles and Bitumen Adhesive
		EXTENT:	12m ²
		ACCESSIBILITY:	Occasionally likely to be disturbed

MATERIAL ASSESSMENT (MA)			SAMPLE INFORMATION	
MC:	Low Damage	1	LEVEL OF IDENTIFICATION:	Referred to a visually identical material
ST:	Composite Material	0	SAMPLE REFERENCE:	As NR007607*
PT:	Floor Tiles & Bitumen Adhesive	1	ASBESTOS TYPE 1 (AT):	Chrysotile
ASBESTOS TYPE (AT) SCORE:		1	ASBESTOS TYPE 2 (AT):	N/A
ALGORITHM SCORE:		3	ASBESTOS TYPE 3 (AT):	N/A
RISK LEVEL:		Very Low	MATERIAL CLASSIFICATION:	Floor Tiles & Bitumen Adhesive

RECOMMENDATION:	Manage & Monitor Condition
SURVEYORS COMMENT:	Continue to manage and monitor item in situ.

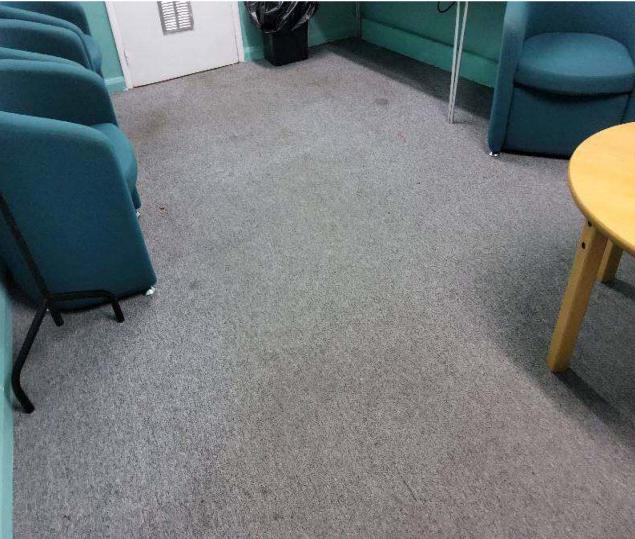
FINDING REFERENCE:		16	LOCATION, DESCRIPTION & EXTENT

BUILDING:	Main Building
			FLOOR:	Ground Floor
			AREA:	Office
			LOCATION:	To Concrete Floor (Below Modern Vinyl and Carpet Tiles)
			DESCRIPTION:	Bitumen Adhesive
			EXTENT:	12m ²
			ACCESSIBILITY:	Occasionally likely to be disturbed

MATERIAL ASSESSMENT (MA)			SAMPLE INFORMATION	
MC:	Good Condition	0	LEVEL OF IDENTIFICATION:	Referred to a visually identical material
ST:	Composite Material	0	SAMPLE REFERENCE:	As NR007606*
PT:	Bitumen Products	1	ASBESTOS TYPE 1 (AT):	Chrysotile
ASBESTOS TYPE (AT) SCORE:		1	ASBESTOS TYPE 2 (AT):	N/A
ALGORITHM SCORE:		2	ASBESTOS TYPE 3 (AT):	N/A
RISK LEVEL:		Very Low	MATERIAL CLASSIFICATION:	Bitumen Products

RECOMMENDATION:	Manage & Monitor Condition
SURVEYORS COMMENT:	Continue to manage and monitor item in situ.

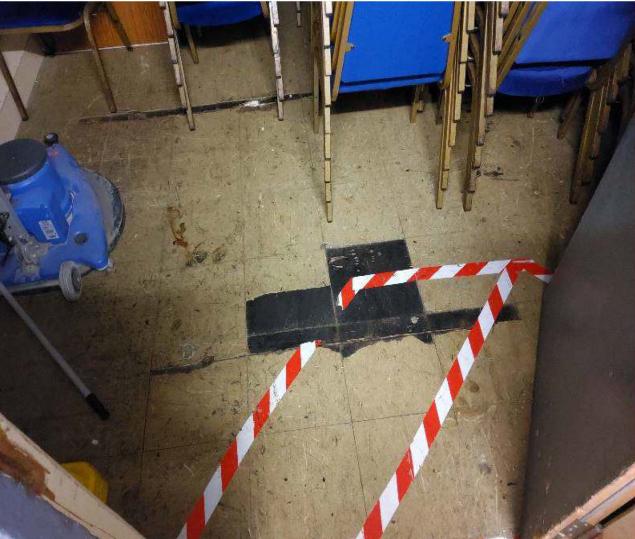
FINDING REFERENCE:		17	LOCATION, DESCRIPTION & EXTENT

BUILDING:	Main Building
			FLOOR:	Ground Floor
			AREA:	Table Office
			LOCATION:	To Timber Floor
			DESCRIPTION:	Floor Tiles and Bitumen Adhesive
			EXTENT:	6m ²
			ACCESSIBILITY:	Routinely disturbed

MATERIAL ASSESSMENT (MA)			SAMPLE INFORMATION	
MC:	Low Damage	1	LEVEL OF IDENTIFICATION:	Sampled + Analysed
ST:	Composite Material	0	SAMPLE REFERENCE:	NR007608*
PT:	Floor Tiles & Bitumen Adhesive	1	ASBESTOS TYPE 1 (AT):	Chrysotile
ASBESTOS TYPE (AT) SCORE:		1	ASBESTOS TYPE 2 (AT):	N/A
ALGORITHM SCORE:		3	ASBESTOS TYPE 3 (AT):	N/A
RISK LEVEL:	Very Low		MATERIAL CLASSIFICATION:	Floor Tiles & Bitumen Adhesive

RECOMMENDATION:	Manage & Monitor Condition
SURVEYORS COMMENT:	Continue to manage and monitor item in situ.

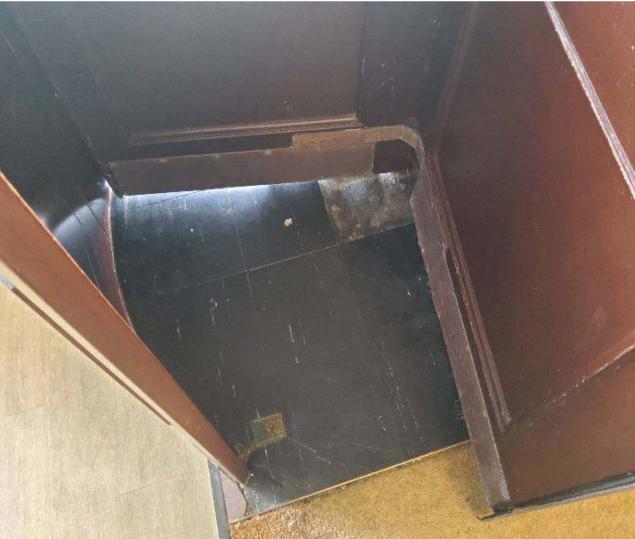
FINDING REFERENCE:	18	LOCATION, DESCRIPTION & EXTENT

BUILDING:	Main Building
		FLOOR:	Ground Floor
		AREA:	Foyer
		LOCATION:	To Concrete Floor of Turnstile
		DESCRIPTION:	Vinyl Floor Tiles and Bitumen Adhesive
		EXTENT:	3m ²
		ACCESSIBILITY:	Routinely disturbed

MATERIAL ASSESSMENT (MA)			SAMPLE INFORMATION	
MC:	Medium Damage	2	LEVEL OF IDENTIFICATION:	Sampled + Analysed
ST:	Composite Material	0	SAMPLE REFERENCE:	NR007609*
PT:	Floor Tiles & Bitumen Adhesive	1	ASBESTOS TYPE 1 (AT):	Chrysotile
ASBESTOS TYPE (AT) SCORE:		1	ASBESTOS TYPE 2 (AT):	N/A
ALGORITHM SCORE:	4		ASBESTOS TYPE 3 (AT):	N/A
RISK LEVEL:	Very Low		MATERIAL CLASSIFICATION:	Floor Tiles & Bitumen Adhesive

RECOMMENDATION:	Manage & Monitor Condition
SURVEYORS COMMENT:	Continue to manage and monitor item in situ.

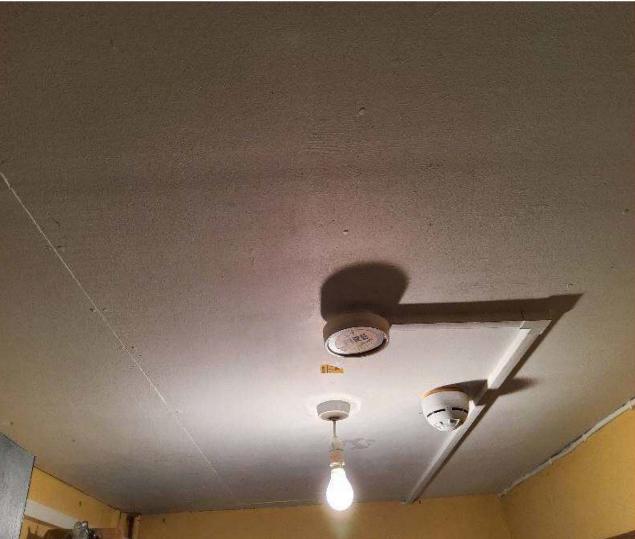
FINDING REFERENCE:	19	LOCATION, DESCRIPTION & EXTENT

BUILDING:	Main Building
		FLOOR:	Ground Floor
		AREA:	CCTV Room
		LOCATION:	To Ceiling
		DESCRIPTION:	Insulating Board Panels
		EXTENT:	3m ²
		ACCESSIBILITY:	Occasionally likely to be disturbed

MATERIAL ASSESSMENT (MA)			SAMPLE INFORMATION	
MC:	Good Condition	0	LEVEL OF IDENTIFICATION:	Presumed
ST:	Surface Sealed / Enclosed Lagging & Sprays	1	SAMPLE REFERENCE:	Visual
PT:	Insulating Board	2	ASBESTOS TYPE 1 (AT):	Amosite
ASBESTOS TYPE (AT) SCORE:	2	2	ASBESTOS TYPE 2 (AT):	N/A
ALGORITHM SCORE:	5	5	ASBESTOS TYPE 3 (AT):	N/A
RISK LEVEL:	Low	Low	MATERIAL CLASSIFICATION:	Insulating Board

RECOMMENDATION:	Manage & Monitor Condition
SURVEYORS COMMENT:	Previously Presumed Amosite. Item previously identified within on-site Asbestos Register. No sample obtained so not to disturb encapsulation. Continue to manage and monitor item in situ.

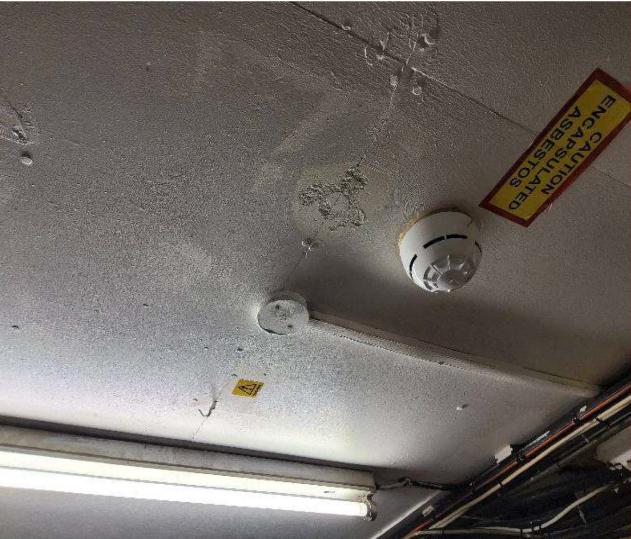
FINDING REFERENCE:	21	LOCATION, DESCRIPTION & EXTENT

BUILDING:	Main Building
		FLOOR:	Ground Floor
		AREA:	Intake Room
		LOCATION:	To Ceiling
		DESCRIPTION:	Insulating Board Panels
		EXTENT:	6m ²
		ACCESSIBILITY:	Occasionally likely to be disturbed

MATERIAL ASSESSMENT (MA)			SAMPLE INFORMATION	
MC:	Good Condition	0	LEVEL OF IDENTIFICATION:	Presumed
ST:	Surface Sealed / Enclosed Lagging & Sprays	1	SAMPLE REFERENCE:	Visual
PT:	Insulating Board	2	ASBESTOS TYPE 1 (AT):	Amosite
ASBESTOS TYPE (AT) SCORE:	2	2	ASBESTOS TYPE 2 (AT):	N/A
ALGORITHM SCORE:	5	5	ASBESTOS TYPE 3 (AT):	N/A
RISK LEVEL:	Low	Low	MATERIAL CLASSIFICATION:	Insulating Board

RECOMMENDATION:	Manage & Monitor Condition
SURVEYORS COMMENT:	Previously Presumed Amosite. Item previously identified within on-site Asbestos Register. No sample obtained so not to disturb encapsulation. Continue to manage and monitor item in situ.

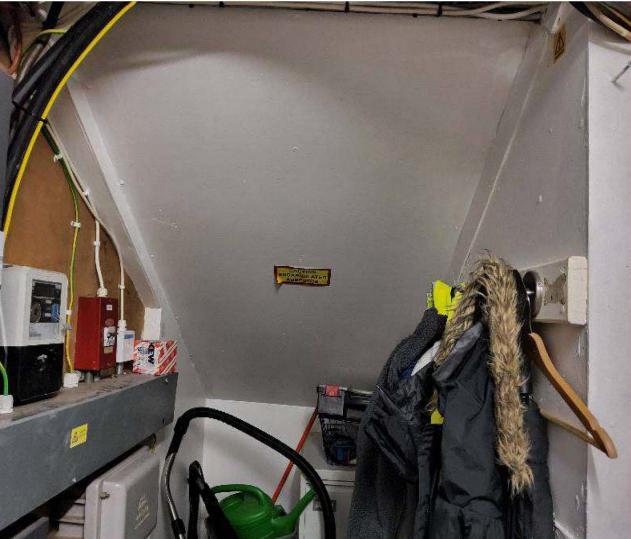
FINDING REFERENCE:	23	LOCATION, DESCRIPTION & EXTENT

BUILDING:	Main Building
		FLOOR:	Ground Floor
		AREA:	Intake Room
		LOCATION:	To Walls and Ceiling of Underside of Stairs
		DESCRIPTION:	Insulating Board
		EXTENT:	10m ²
		ACCESSIBILITY:	Occasionally likely to be disturbed

MATERIAL ASSESSMENT (MA)			SAMPLE INFORMATION	
MC:	Good Condition	0	LEVEL OF IDENTIFICATION:	Presumed
ST:	Surface Sealed / Enclosed Lagging & Sprays	1	SAMPLE REFERENCE:	Visual
PT:	Insulating Board	2	ASBESTOS TYPE 1 (AT):	Amosite
ASBESTOS TYPE (AT) SCORE:	2	2	ASBESTOS TYPE 2 (AT):	N/A
ALGORITHM SCORE:	5	5	ASBESTOS TYPE 3 (AT):	N/A
RISK LEVEL:	Low	Low	MATERIAL CLASSIFICATION:	Insulating Board

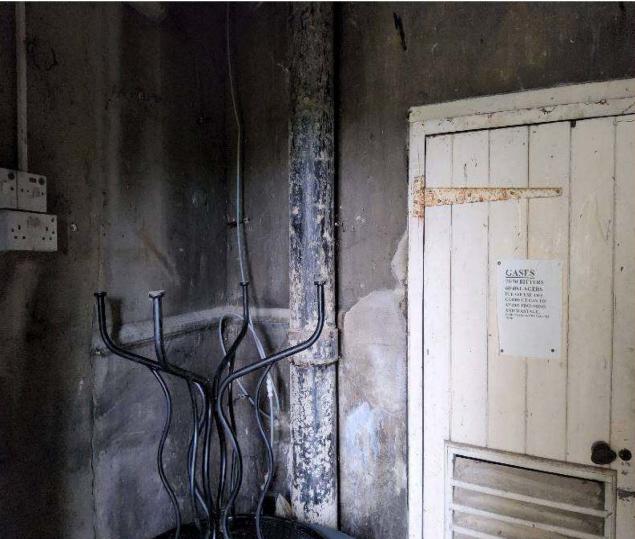
FINDING REFERENCE:	25	LOCATION, DESCRIPTION & EXTENT

BUILDING:	Main Building
		FLOOR:	External
		AREA:	External Store
		LOCATION:	To Wall
		DESCRIPTION:	Composite Pipe
		EXTENT:	5m
		ACCESSIBILITY:	Easily disturbed

MATERIAL ASSESSMENT (MA)			SAMPLE INFORMATION	
MC:	Low Damage	1	LEVEL OF IDENTIFICATION:	Sampled + Analysed
ST:	Composite Material	0	SAMPLE REFERENCE:	NR007617*
PT:	Reinforced Composite	1	ASBESTOS TYPE 1 (AT):	Chrysotile
ASBESTOS TYPE (AT) SCORE:	1	1	ASBESTOS TYPE 2 (AT):	N/A
ALGORITHM SCORE:	3	3	ASBESTOS TYPE 3 (AT):	N/A
RISK LEVEL:	Very Low		MATERIAL CLASSIFICATION:	Reinforced Composite
