**ASBESTOS MANAGEMENT SURVEY REPORT  
FOR ASBESTOS MATERIALS AT:**

Newspaper House  
29 Simmonds Road, Canterbury  
CT1 3YR

Canterbury City Council  
Military Road  
Canterbury, Kent  
CT1 1YW

PROJECT MANAGER:	JAMES PULLEN
ISSUE DATE:	31 May 2024
JOB NUMBER:	J029238
PROJECT REFERENCE:	FW-040
UPRN REFERENCE:	100062280109
VERSION NUMBER:	V1
PAGE NUMBER:	1 OF 43

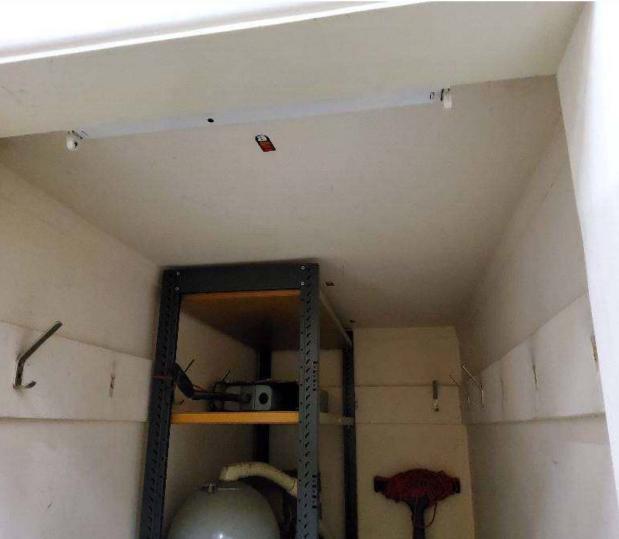
FINDING REFERENCE:	3	LOCATION, DESCRIPTION & EXTENT	
		BUILDING:	Main Building

FLOOR:	1st Floor
		AREA:	Hoover Cupboard
		LOCATION:	To Ceiling
		DESCRIPTION:	Insulating Board Panel
		EXTENT:	2m <sup>2</sup>
		ACCESSIBILITY:	Occasionally likely to be disturbed

MATERIAL ASSESSMENT (MA)			SAMPLE INFORMATION	
MC:	Good Condition	0	LEVEL OF IDENTIFICATION:	Sampled + Analysed
ST:	Surface Sealed / Enclosed Lagging & Sprays	1	SAMPLE REFERENCE:	NR008800
PT:	Insulating Board	2	ASBESTOS TYPE 1 (AT):	Amosite
ASBESTOS TYPE (AT) SCORE:	2	2	ASBESTOS TYPE 2 (AT):	N/A
ALGORITHM SCORE:	5	5	ASBESTOS TYPE 3 (AT):	N/A
RISK LEVEL:	Low	Low	MATERIAL CLASSIFICATION:	Insulating Board

RECOMMENDATION:	Manage & Monitor Condition
SURVEYORS COMMENT:	Continue to manage and monitor item in situ.

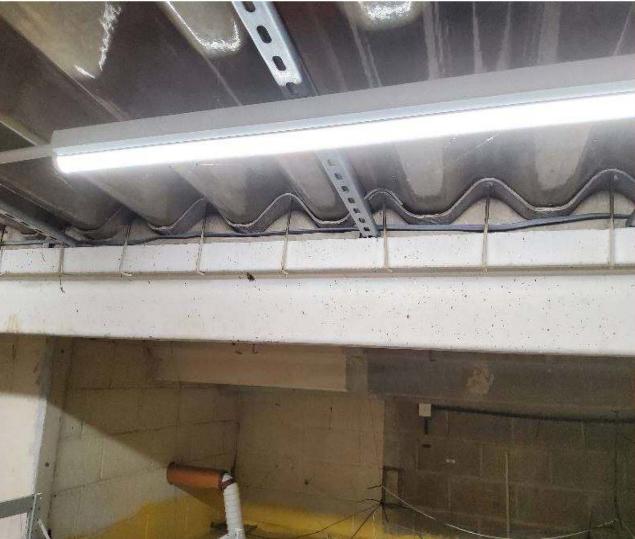
FINDING REFERENCE:	7	LOCATION, DESCRIPTION & EXTENT

BUILDING:	Main Building
		FLOOR:	External
		AREA:	Roof
		LOCATION:	To Upper and Lower Roofs
		DESCRIPTION:	Corrugated Cement Sheets
		EXTENT:	400m <sup>2</sup>
		ACCESSIBILITY:	Usually inaccessible or unlikely to be disturbed

MATERIAL ASSESSMENT (MA)			SAMPLE INFORMATION	
MC:	Low Damage	1	LEVEL OF IDENTIFICATION:	Sampled + Analysed
ST:	Surface Sealed / Enclosed Lagging & Sprays	1	SAMPLE REFERENCE:	NR008803
PT:	Cement	1	ASBESTOS TYPE 1 (AT):	Chrysotile
ASBESTOS TYPE (AT) SCORE:		1	ASBESTOS TYPE 2 (AT):	N/A
ALGORITHM SCORE:	4		ASBESTOS TYPE 3 (AT):	N/A
RISK LEVEL:	Very Low		MATERIAL CLASSIFICATION:	Cement

RECOMMENDATION:	Manage & Monitor Condition
SURVEYORS COMMENT:	The roofs are overlaid in metal sheeting but cement can be seen internally in multiple locations Continue to manage and monitor item in situ.

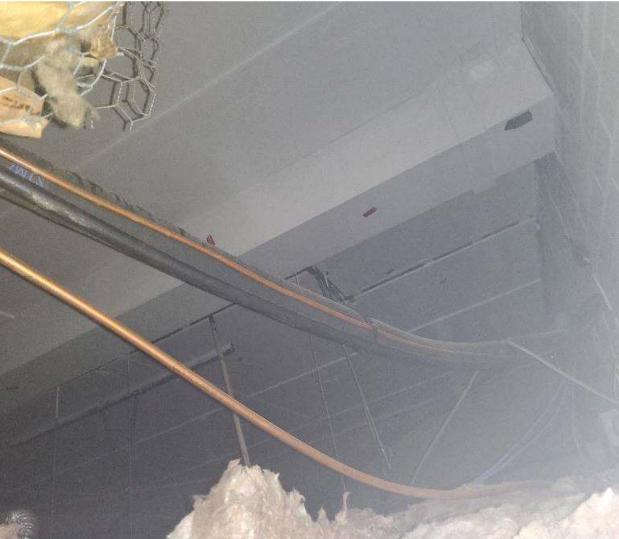
FINDING REFERENCE:	10	LOCATION, DESCRIPTION & EXTENT

BUILDING:	Main Building
		FLOOR:	Ground Floor
		AREA:	Small Finds Archive
		LOCATION:	To Ceiling and Beams
		DESCRIPTION:	Insulating Board Panels & Cladding
		EXTENT:	40m <sup>2</sup>
		ACCESSIBILITY:	Usually inaccessible or unlikely to be disturbed

MATERIAL ASSESSMENT (MA)			SAMPLE INFORMATION	
MC:	Good Condition	0	LEVEL OF IDENTIFICATION:	Presumed
ST:	Surface Sealed / Enclosed Lagging & Sprays	1	SAMPLE REFERENCE:	Visual
PT:	Insulating Board	2	ASBESTOS TYPE 1 (AT):	Amosite
ASBESTOS TYPE (AT) SCORE:	2	2	ASBESTOS TYPE 2 (AT):	N/A
ALGORITHM SCORE:	5	5	ASBESTOS TYPE 3 (AT):	N/A
RISK LEVEL:	Low	Low	MATERIAL CLASSIFICATION:	Insulating Board

RECOMMENDATION:	Manage & Monitor Condition
SURVEYORS COMMENT:	Presumed Amosite. Unable to sample due to being over safe working height. Continue to manage and monitor item in situ.

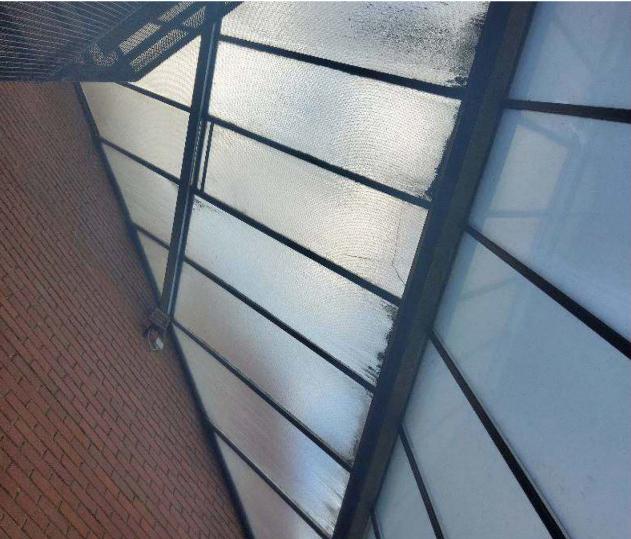
FINDING REFERENCE:	11	LOCATION, DESCRIPTION & EXTENT

BUILDING:	Main Building
		FLOOR:	Ground Floor
		AREA:	Reception
		LOCATION:	To Skylights
		DESCRIPTION:	Rope Seals
		EXTENT:	24lm
		ACCESSIBILITY:	Usually inaccessible or unlikely to be disturbed

MATERIAL ASSESSMENT (MA)			SAMPLE INFORMATION	
MC:	Good Condition	0	LEVEL OF IDENTIFICATION:	Presumed
ST:	Surface Sealed / Enclosed Lagging & Sprays	1	SAMPLE REFERENCE:	Visual
PT:	Textiles/Paper	2	ASBESTOS TYPE 1 (AT):	Chrysotile
ASBESTOS TYPE (AT) SCORE:	1	1	ASBESTOS TYPE 2 (AT):	N/A
ALGORITHM SCORE:	4	4	ASBESTOS TYPE 3 (AT):	N/A
RISK LEVEL:	Very Low		MATERIAL CLASSIFICATION:	Textiles/Paper

RECOMMENDATION:	Manage & Monitor Condition
SURVEYORS COMMENT:	Presumed Chrysotile. Unable to sample due to being over safe working height and damage to integrity. Continue to manage and monitor item in situ.

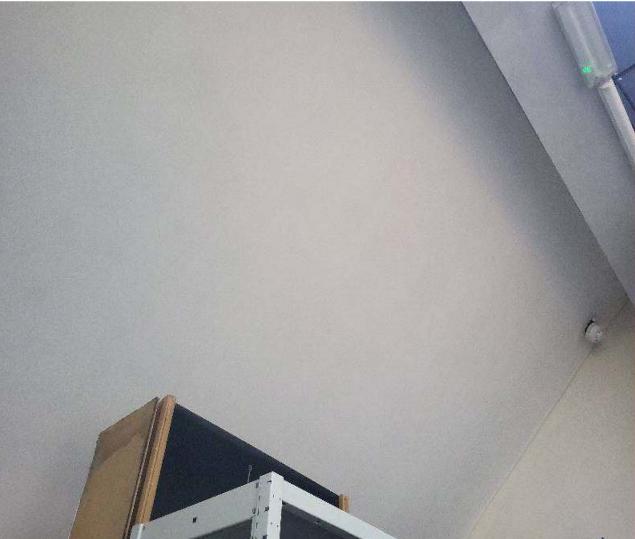
FINDING REFERENCE:	12	LOCATION, DESCRIPTION & EXTENT

BUILDING:	Main Building
		FLOOR:	Ground Floor
		AREA:	Reception
		LOCATION:	Above New Plasterboard Ceiling
		DESCRIPTION:	Insulating Board Ceiling Panels and Beam Cladding
		EXTENT:	10m <sup>2</sup>
		ACCESSIBILITY:	Usually inaccessible or unlikely to be disturbed

MATERIAL ASSESSMENT (MA)			SAMPLE INFORMATION	
MC:	Good Condition	0	LEVEL OF IDENTIFICATION:	Presumed
ST:	Surface Sealed / Enclosed Lagging & Sprays	1	SAMPLE REFERENCE:	Visual
PT:	Insulating Board	2	ASBESTOS TYPE 1 (AT):	Amosite
ASBESTOS TYPE (AT) SCORE:	2	2	ASBESTOS TYPE 2 (AT):	N/A
ALGORITHM SCORE:	5	5	ASBESTOS TYPE 3 (AT):	N/A
RISK LEVEL:	Low	Low	MATERIAL CLASSIFICATION:	Insulating Board

RECOMMENDATION:	Manage & Monitor Condition
SURVEYORS COMMENT:	Presumed Amosite. This item has previously been identified in a historical report, however, due to new plasterboard ceilings we are unable to confirm existence and the item is presumed to still be present. Continue to manage and monitor item in situ.

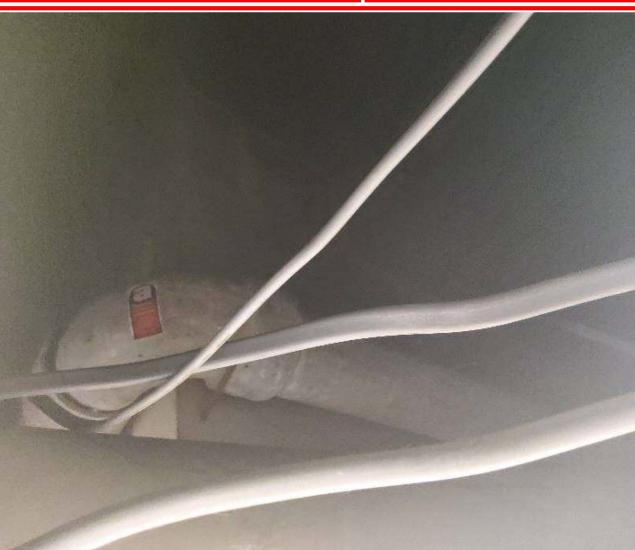
FINDING REFERENCE:	14	LOCATION, DESCRIPTION & EXTENT

BUILDING:	Main Building
		FLOOR:	1st Floor
		AREA:	Female WC
		LOCATION:	Above False Ceiling
		DESCRIPTION:	Cement Flue Pipe
		EXTENT:	3m
		ACCESSIBILITY:	Occasionally likely to be disturbed

MATERIAL ASSESSMENT (MA)			SAMPLE INFORMATION	
MC:	Good Condition	0	LEVEL OF IDENTIFICATION:	Sampled + Analysed
ST:	Surface Sealed / Enclosed Lagging & Sprays	1	SAMPLE REFERENCE:	NR009520
PT:	Cement	1	ASBESTOS TYPE 1 (AT):	Chrysotile
ASBESTOS TYPE (AT) SCORE:		1	ASBESTOS TYPE 2 (AT):	N/A
ALGORITHM SCORE:	3		ASBESTOS TYPE 3 (AT):	N/A
RISK LEVEL:	Very Low		MATERIAL CLASSIFICATION:	Cement

RECOMMENDATION:	Manage & Monitor Condition
SURVEYORS COMMENT:	Continue to manage and monitor item in situ.

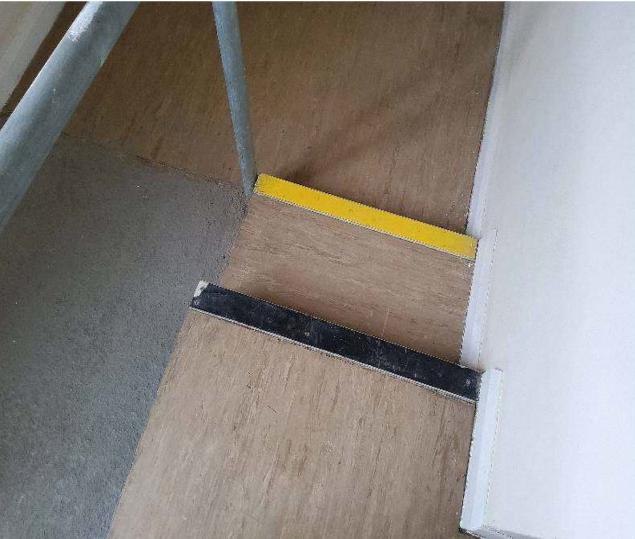
FINDING REFERENCE:	2	LOCATION, DESCRIPTION & EXTENT

BUILDING:	Main Building	
	FLOOR:	Ground Floor	
	AREA:	Corridor	
	LOCATION:	To Step	
	DESCRIPTION:	Composite Stair Nosing (Black)	
	EXTENT:	1lm	
	ACCESSIBILITY:	Routinely disturbed

MATERIAL ASSESSMENT (MA)			SAMPLE INFORMATION	
MC:	N/A	N/A	LEVEL OF IDENTIFICATION:	Sampled + Analysed
ST:	N/A	N/A	SAMPLE REFERENCE:	NR008799
PT:	N/A	N/A	ASBESTOS TYPE 1 (AT):	No Asbestos Detected
ASBESTOS TYPE (AT) SCORE:	N/A	N/A	ASBESTOS TYPE 2 (AT):	N/A
ALGORITHM SCORE:	N/A	N/A	ASBESTOS TYPE 3 (AT):	N/A
RISK LEVEL:	N/A	N/A	MATERIAL CLASSIFICATION:	Non-Asbestos Material

RECOMMENDATION:	No further action required.
SURVEYORS COMMENT:	No asbestos detected.

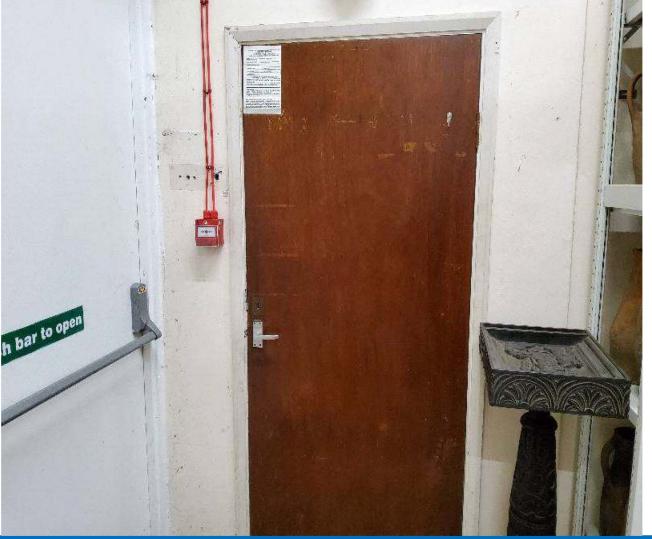
FINDING REFERENCE:	1	LOCATION, DESCRIPTION & EXTENT

1	BUILDING:	Main Building
	FLOOR:	Ground Floor	
	AREA:	Tank Cupboard	
	LOCATION:	Within Tank Cupboard	
	DESCRIPTION:	No Access Within Tank Cupboard

REASON FOR NO ACCESS:	No access within tank cupboard due to the door being locked and no key could be located.
RECOMMENDATION:	ACCESS AND INSPECT PRIOR TO ANY DISTURBANCE WITHIN THIS AREA
