Project:	Nickle Farm Chartham
Origin:	Crowborough
Current Issue:	Approved LGL Date 16/04/18
Prepared:	JF
Approved:	LGL
Size:	A1
Date:	16/04/18
Drawing Status:	PRELIMINARY

Description:	Drainage Strategy Drawing Jocks & Morrello
Scale:	1:1000
Dwg No:	0000/01
Issue:	A

Description:
Standard Details

**Re: Peaches, Jocks Morello and Swallow Fields, Nickle Farm, Kent
Soakage Testing**

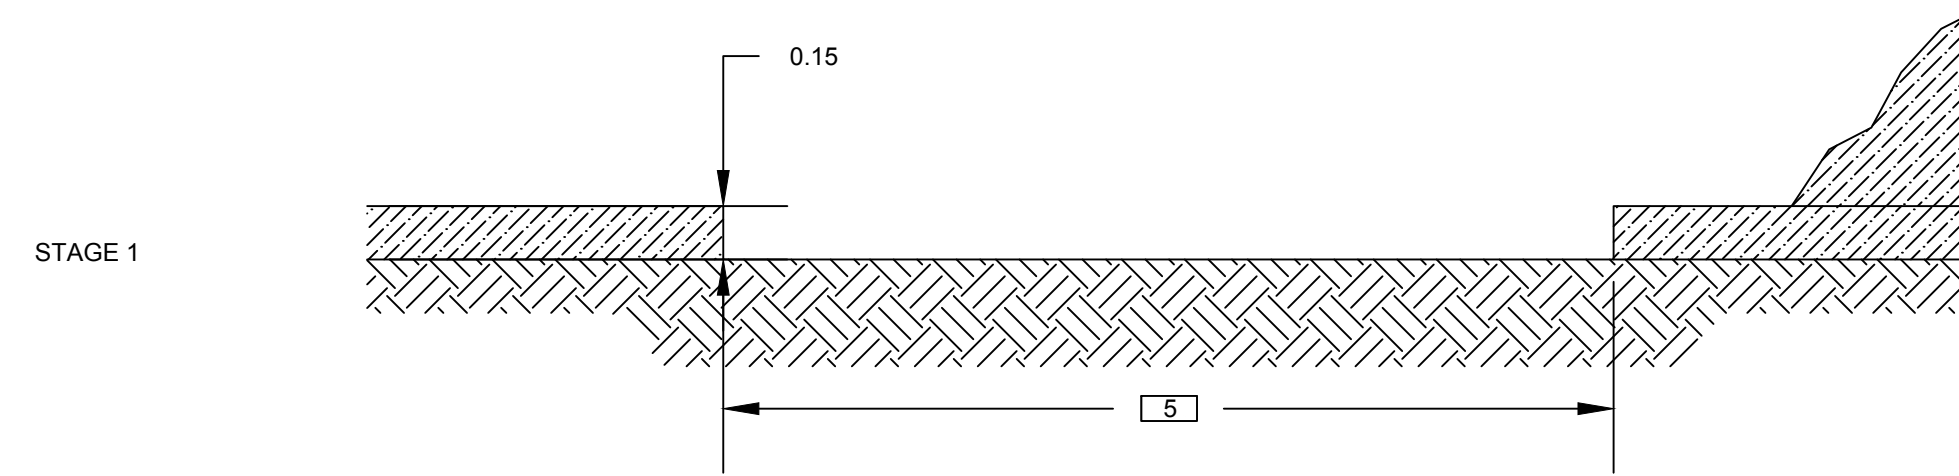
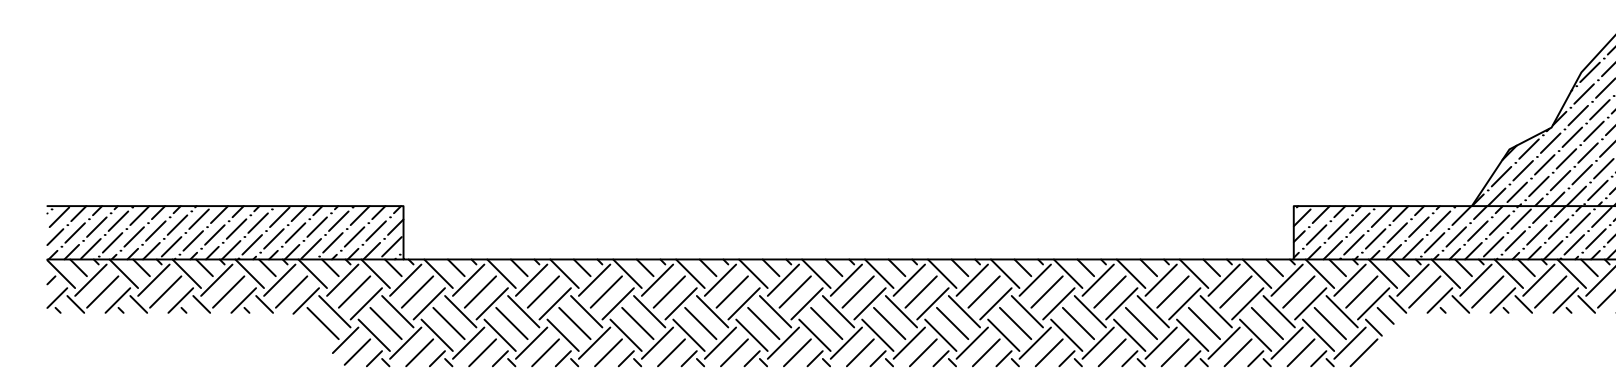
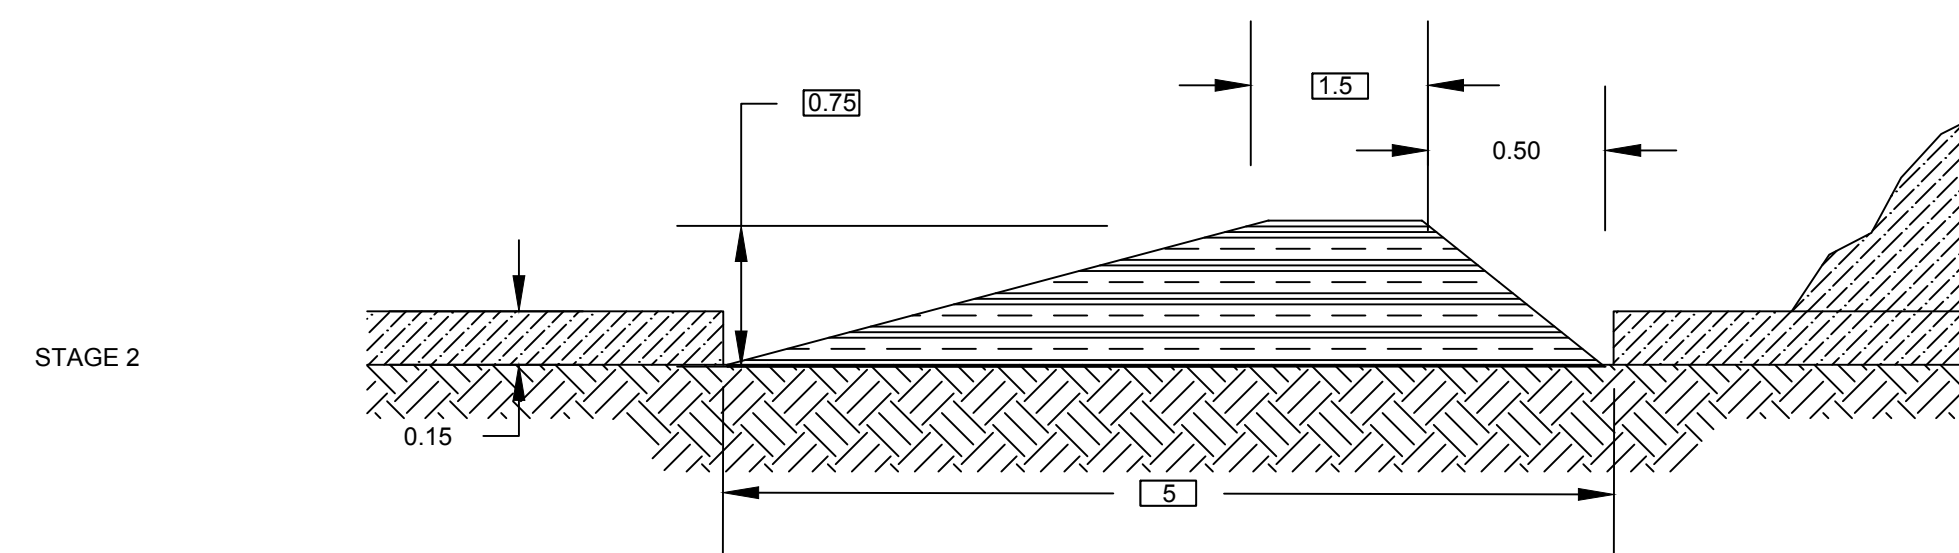
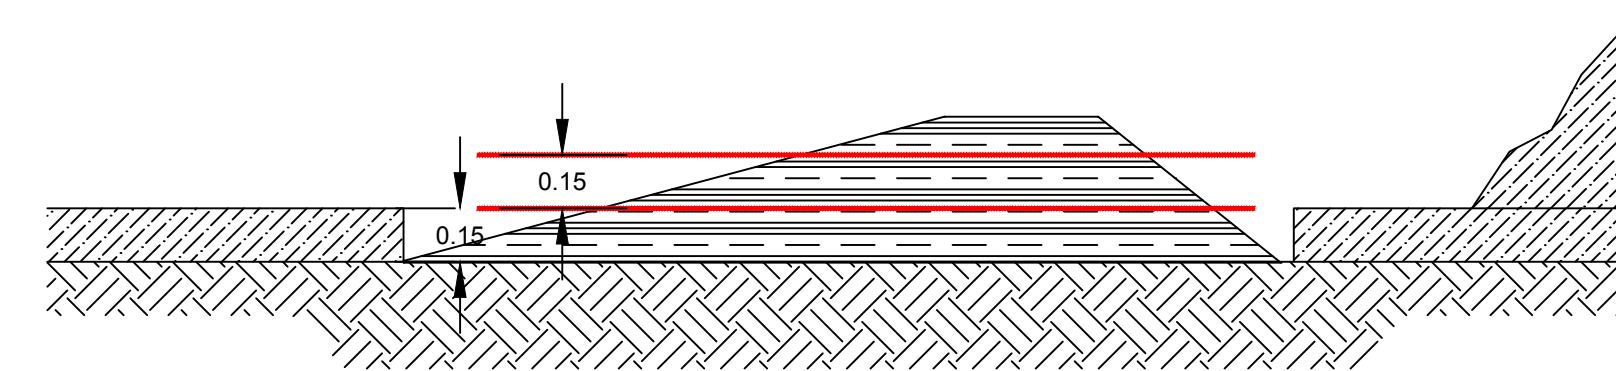
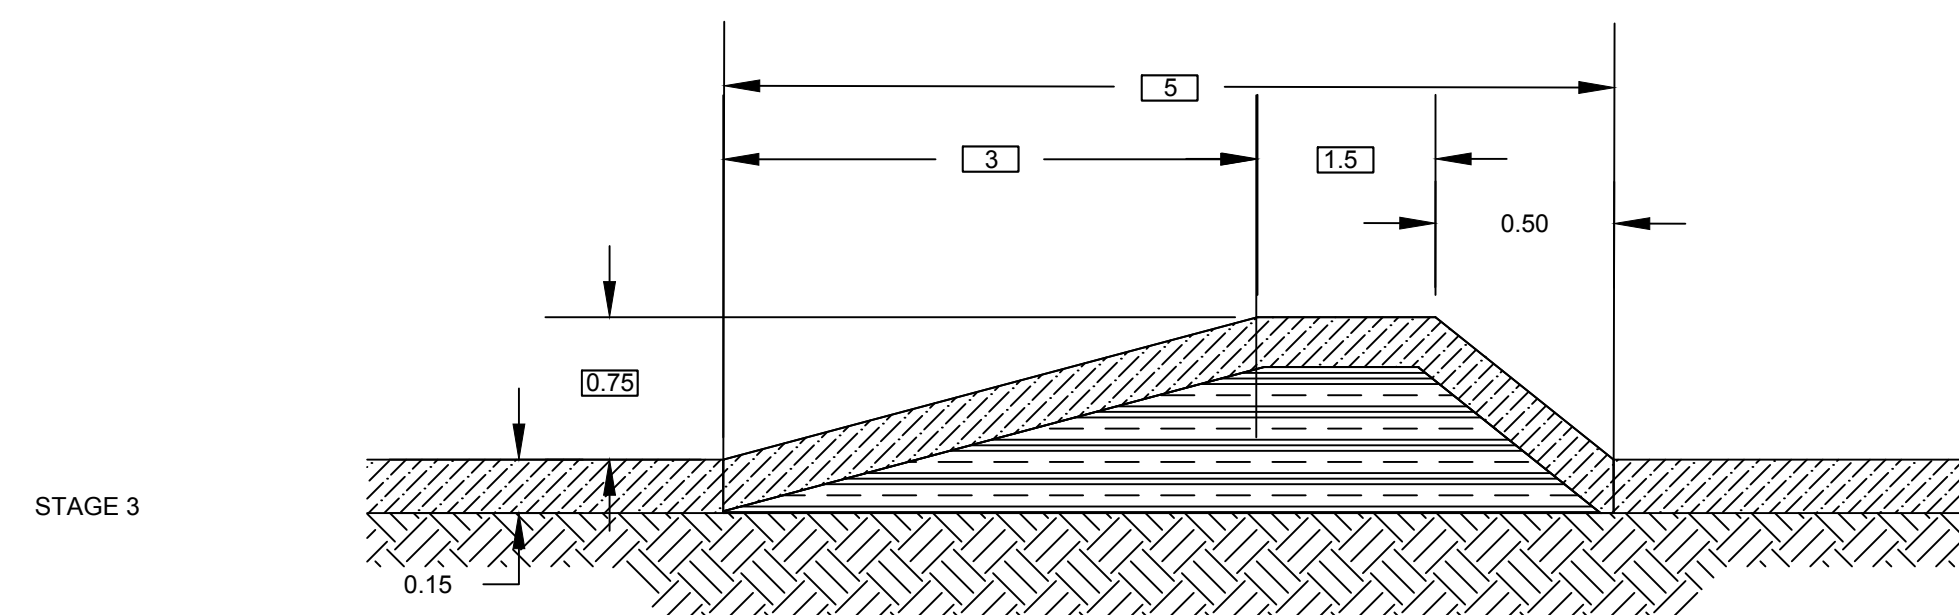
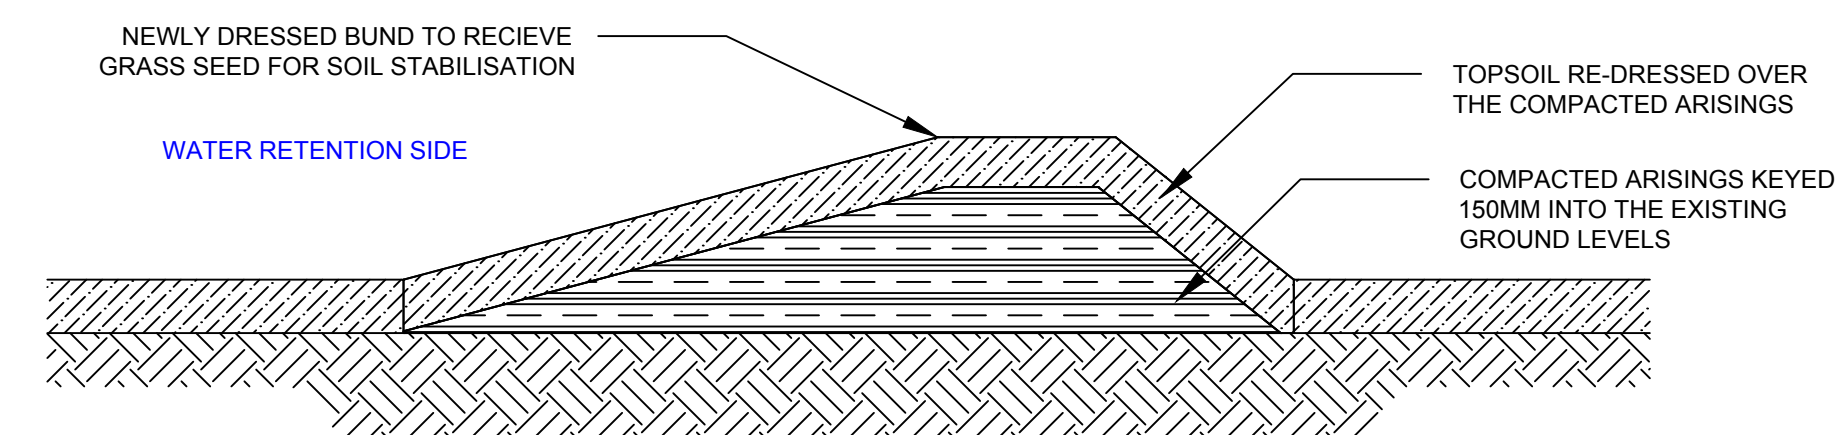
FLOOD RETENTION BUND DETAILS

TOPSOIL TO BE STRIPPED TO A DEPTH OF 150MM AND SET ASIDE FOR REUSE

THE BUND SHALL BE CONSTRUCTED USING THE AVAILABLE ARISINGS FROM THE SOAKAWAY TRENCHES AND COMPACTED IN LAYERS NOT GREATER THAN 150MM EACH LIFT. IT IS ANTICIPATED THAT THE BUND WILL BE OVER CONSTRUCTED FOR THE PURPOSES OF COMPACTION AND THEN SHAPED TO SIZE

NEWLY DRESSED BUND TO RECEIVE GRASS SEED FOR SOIL STABILISATION

WATER RETENTION SIDE

TOPSOIL RE-DRESSED OVER THE COMPACTED ARISINGS

COMPACTED ARISINGS KEYED 150MM INTO THE EXISTING GROUND LEVELS

THE COMPACTED ARISINGS WILL BE RE-DRESSED WITH THE TOPSOIL PREVIOUSLY REMOVED TO ALLOW VEGETATION GROWTH AND QUICK STABILISATION OF THE BUND SOIL.

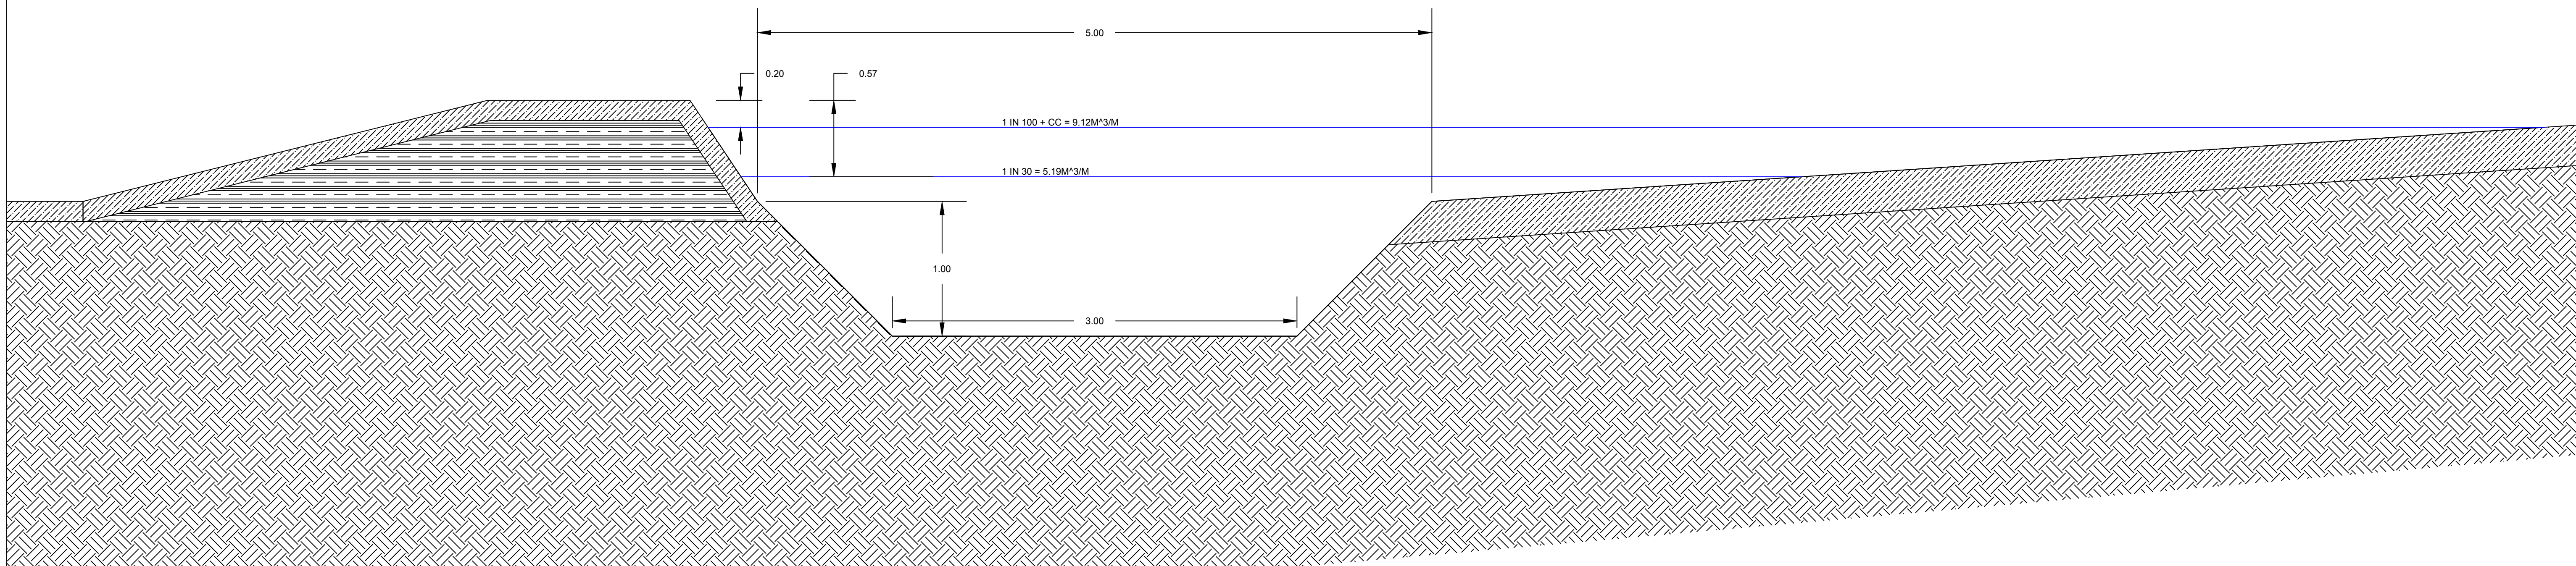
FLOOD RETENTION DITCH & BUND DETAILS

CROSS SECTION

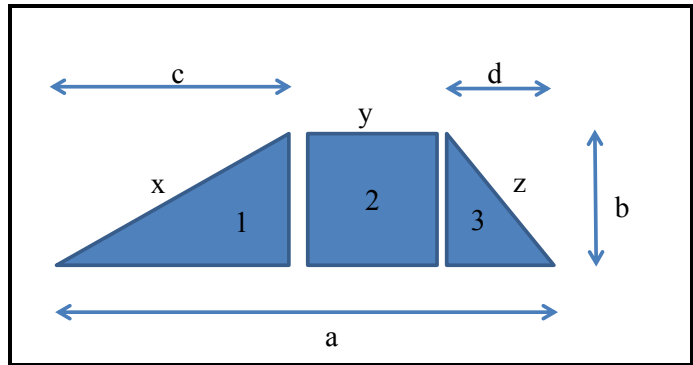
Start of Cross Section	
Length (a)	5 m
Height (b)	0.75 m
Length (c)	3 m
Length (d)	0.5 m
Length (x)	3.092329219 m
Length (y)	1.5 m
Length (z)	0.901387819 m
Angle (Slope x)	14.03624347 °
Angle (Slope z)	56.30993247 °
Cross Section (1)	1.125 m ²
Cross Section (2)	1.125 m ²
Cross Section (3)	0.1875 m ²
Total Cross Section	2.4375 m ²

Average Cross Section	2.4375 m ²
Total Length of Embankment	460 m
Bulk Factor for Re-Compacted Soil	1.05
Volume of Material Calculated	1177.313 m ³

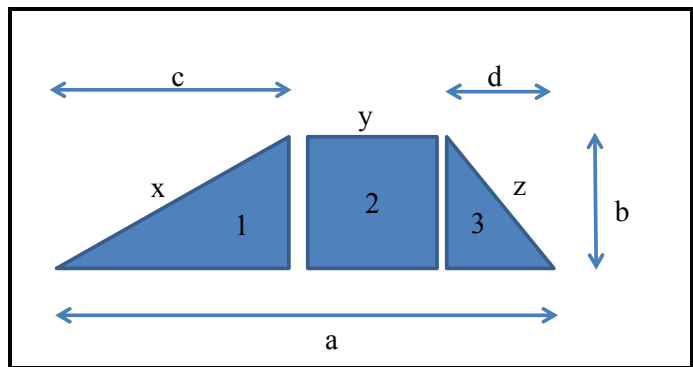
End of Cross Section	
Length (a)	5 m
Height (b)	0.75 m
Length (c)	3 m
Length (d)	0.5 m
Length (x)	3.092329219 m
Length (y)	1.5 m
Length (z)	0.901387819 m
Angle (Slope x)	14.03624347 °
Angle (Slope z)	56.30993247 °
Cross Section (1)	1.125 m ²
Cross Section (2)	1.125 m ²
Cross Section (3)	0.1875 m ²
Total Cross Section	2.4375 m ²
