## TECHNICAL NOTE

| <b>SUBJECT:</b> | University of Kent, Canterbury Campus Access Road Alignment Woodland Impact Review | | |
| <b>PROJECT:</b> | 70080896 | <b>AUTHOR:</b> | Justin Sherlock |

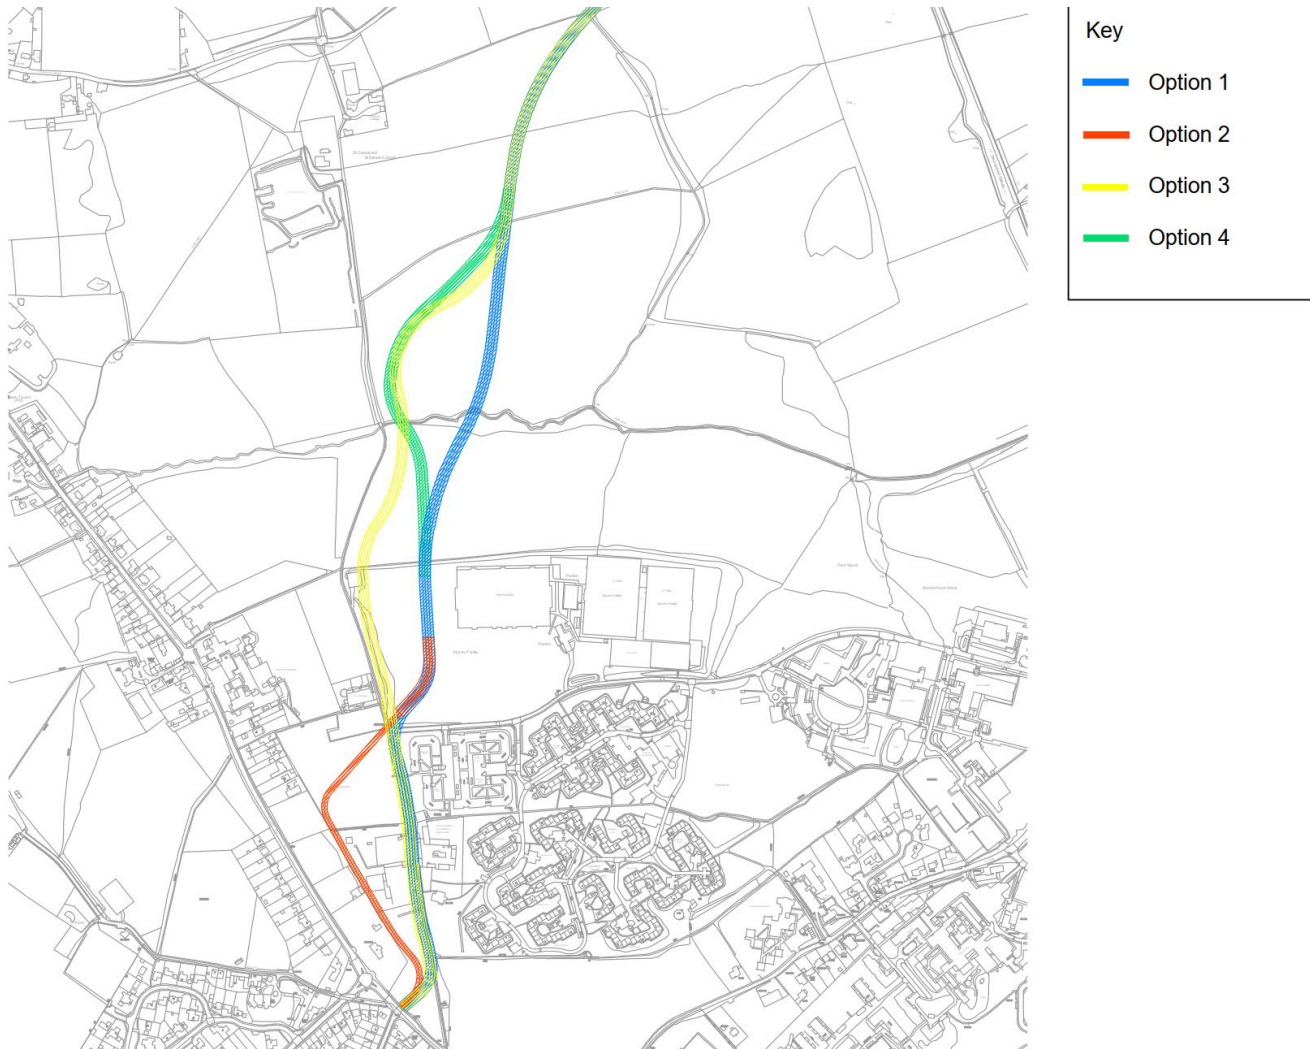
**Figure 4 – Access Road Alignment Options**

Taking account of the constraints identified above a range of alignments were considered for the new access road to determine the potential impacts these may have on the existing University Campus and other constraints identified as part of the environmental studies such as the potential ancient woodland and watercourse. These access road options are shown in **Figure 4**.

Option 3 was identified as being the preferred alignment for the access road through the University and across the proposed development site for the following reasons:

- Minimised impacts on the University Campus including the Sports Pitches;
- Facilitated the University Masterplan by providing an access from Whitstable Road for provision of new car parks and amended bus routes;
- Minimised potential impacts on listed buildings when compared to other options explored;
- The road alignment, once consideration was given to likely earthworks could maintain a buffer to the potential ancient woodland of West Triangle Wood; and
- Through refinement of the design the road could potentially cross through the gap between the West Triangle Wood and the Long Thin Wood. To further minimise impacts in the vicinity of the potential ancient woodland a bridge could be used rather than a cheaper culvert type solution to narrow the alignment of the highway and potentially prevent loss of potential ancient woodland.

All of the options identified for the road involved passing through the area of potential ancient woodland that runs parallel to the watercourse within Site B (Long Thin Wood). In Summer 2021 an initial review of the potential ancient woodland was undertaken by WSP's Arboriculture and Ecology Teams to identify the potential status of the woodland. This review is contained within **Appendix A**. Whilst their review did not identify any trees that would indicate the woodland was ancient (defined as an area of woodland which has been continuously treed from before 1600AD) several trees were noted to have potential veteran characteristics, and these were located throughout the band of woodland.

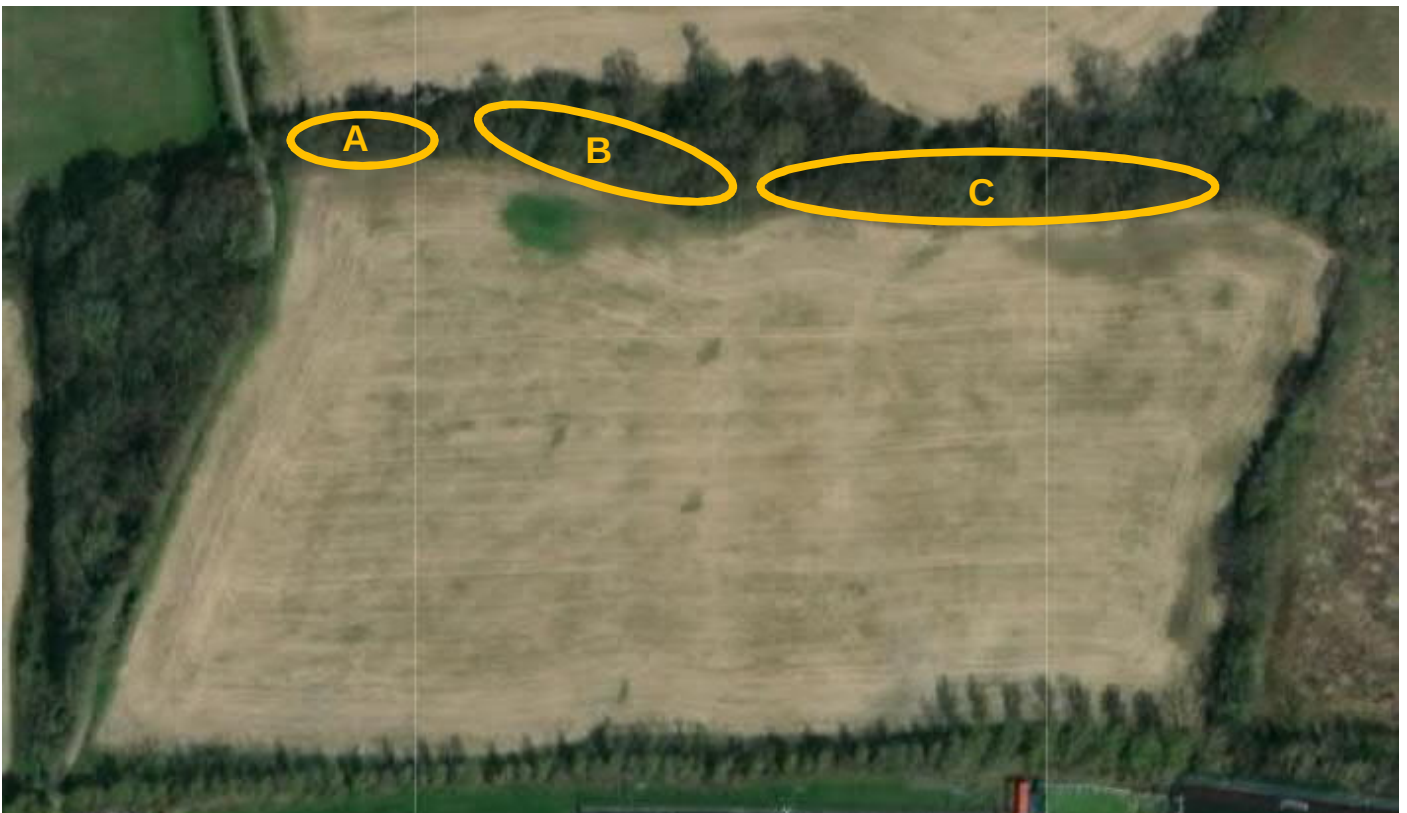
Image 1 – Woodland overview

While there is some variation in species and tree size through the woodland the general quality is relatively consistent. Areas of particular note highlighted in Image 1 are:

It should be noted that throughout the woodland, in areas A, B and C there are trees which have some veteran characteristics. There are several factors that influence whether a tree is a veteran; it is not based solely on size or age. A more detailed inspection of these potentially veteran trees is required to establish whether they should be classified as veteran trees.

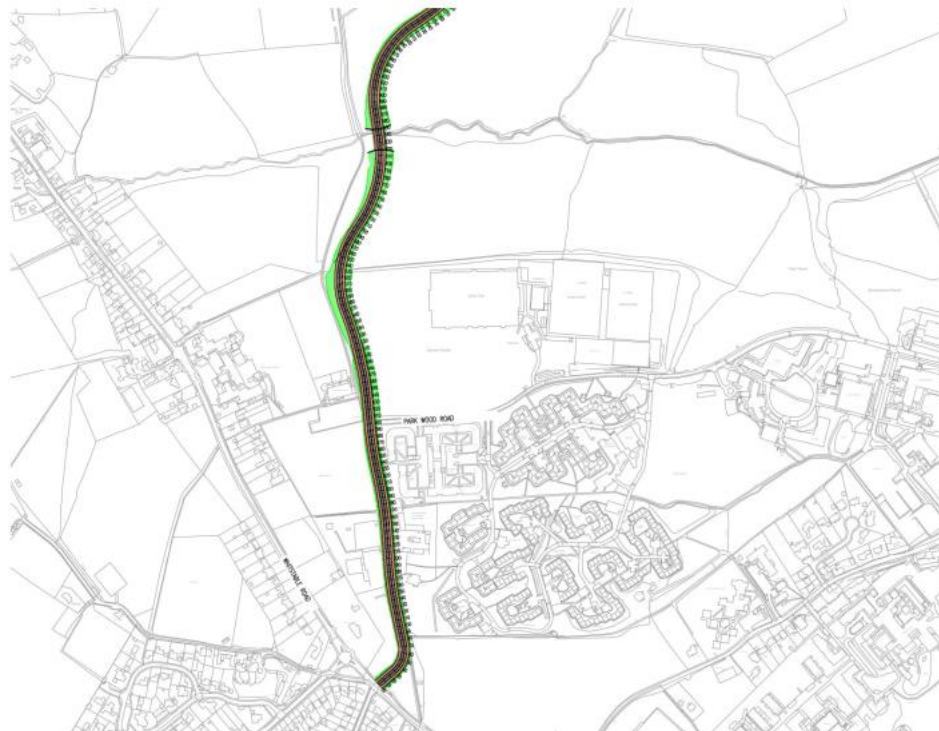
**Figure 1- Site BCD Access Road Alignment**

- 1.1.2. The current route alignment is displayed below in Figure 1. The alignment seeks to follow the Crab and Winkle Way through the University Campus to Park Wood Road where a new junction would be formed. It then continues north on an alignment immediately to the east of the Crab and Winkle Way to minimise impacts on the UoK sports pitches before heading into the agricultural fields maintaining a buffer to the north-south aligned section of potential ancient woodland known as West Triangle Wood. The road then seeks to cross the east-west section of potential ancient woodland known as Long Thin Wood at the western end where the woodland is at its thinnest. North of the watercourse the alignment heads north east across agricultural fields and ties into Tyler Hill Road.

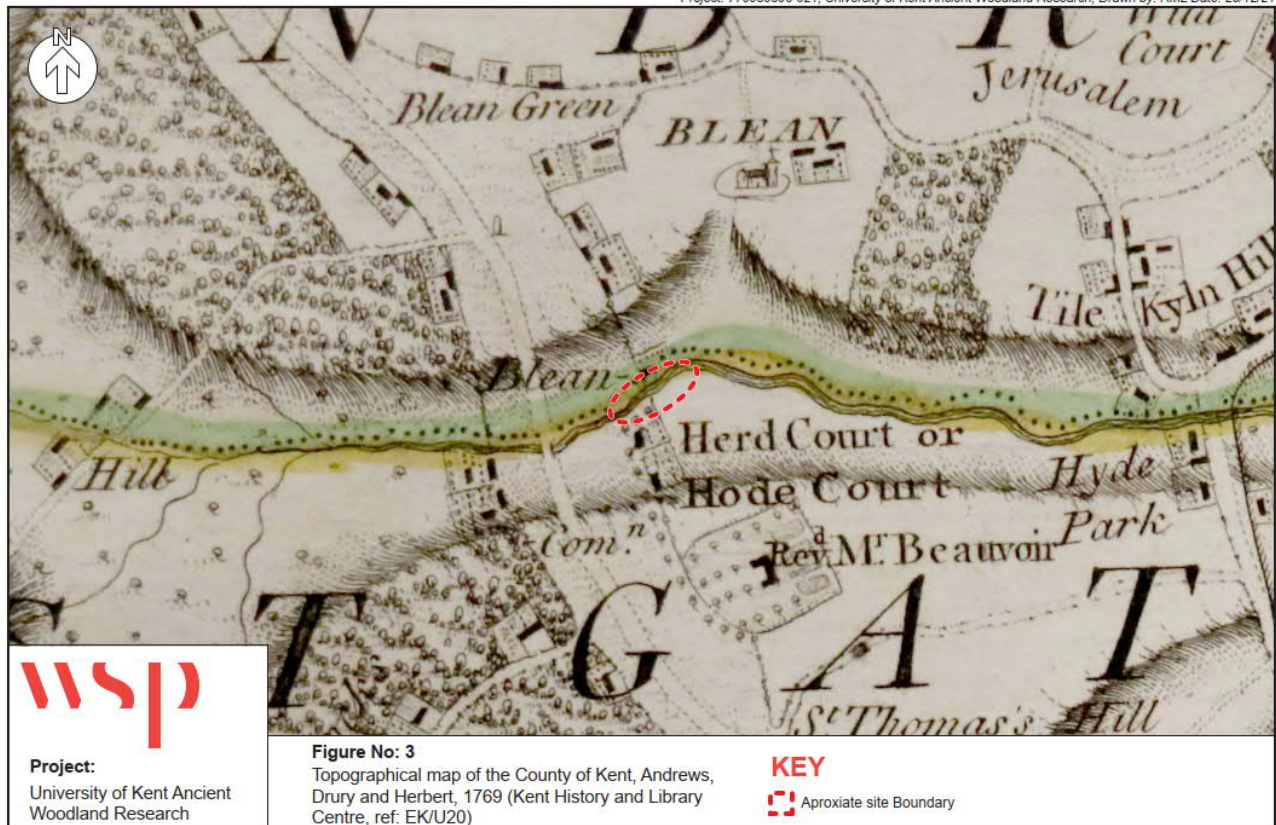
No further detailed maps of the site and surrounding area were identified until the late 18th century. The rather more detailed 1769 map of Kent by Andrews, Drury and Herbert (**Figure 3**) enables one to pinpoint the approximate location of the site more closely since it shows the stream which runs adjacent the north edge of the eastern part of the site and through the western part of the site.
