Site : *1 – 2 Vulcan Close
Whitstable
Kent
CT5 4LZ*

Date : *4th August 2015*

CCTV Survey Report

Survey Ref : *TV150808*

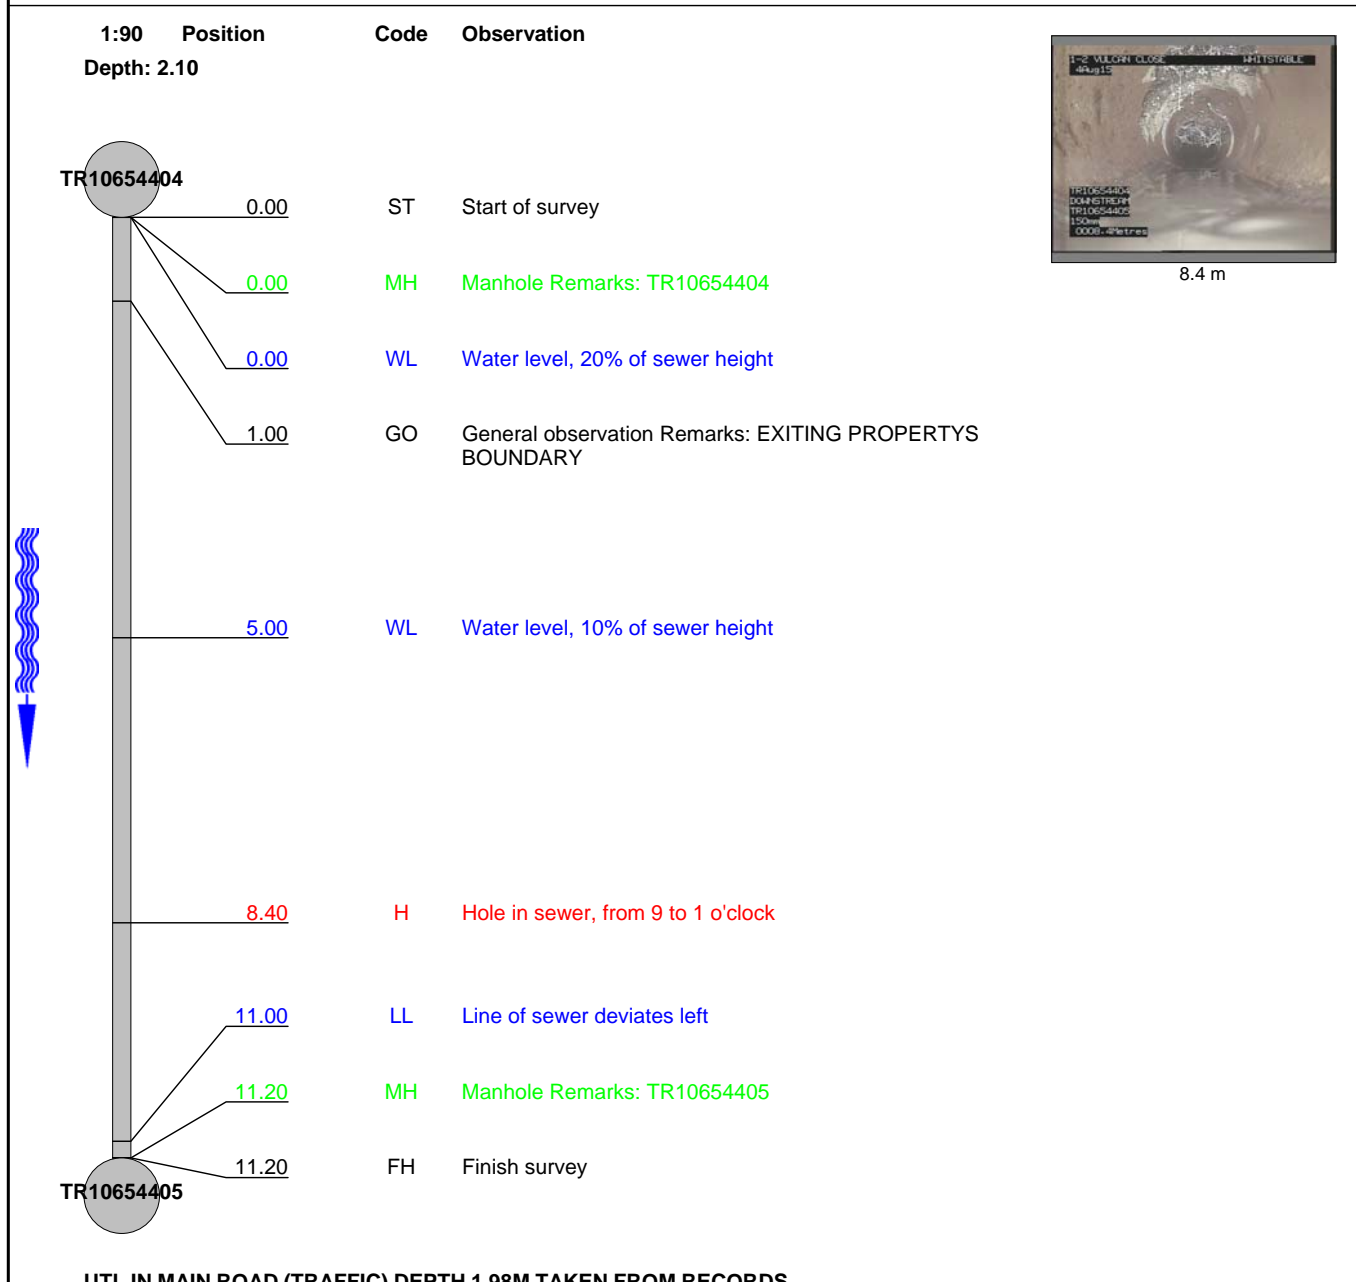
UTL IN MAIN ROAD (TRAFFIC) DEPTH 1.98M TAKEN FROM RECORDS

Structural Defects					Constructional Features				
Service Defects					Miscellaneous Features				
STR no def	STR peak	STR mean	STR total	STR grade	SER no def	SER peak	SER mean	SER total	SER grade
1	165	14.73	165	5	0	0	0	0	1

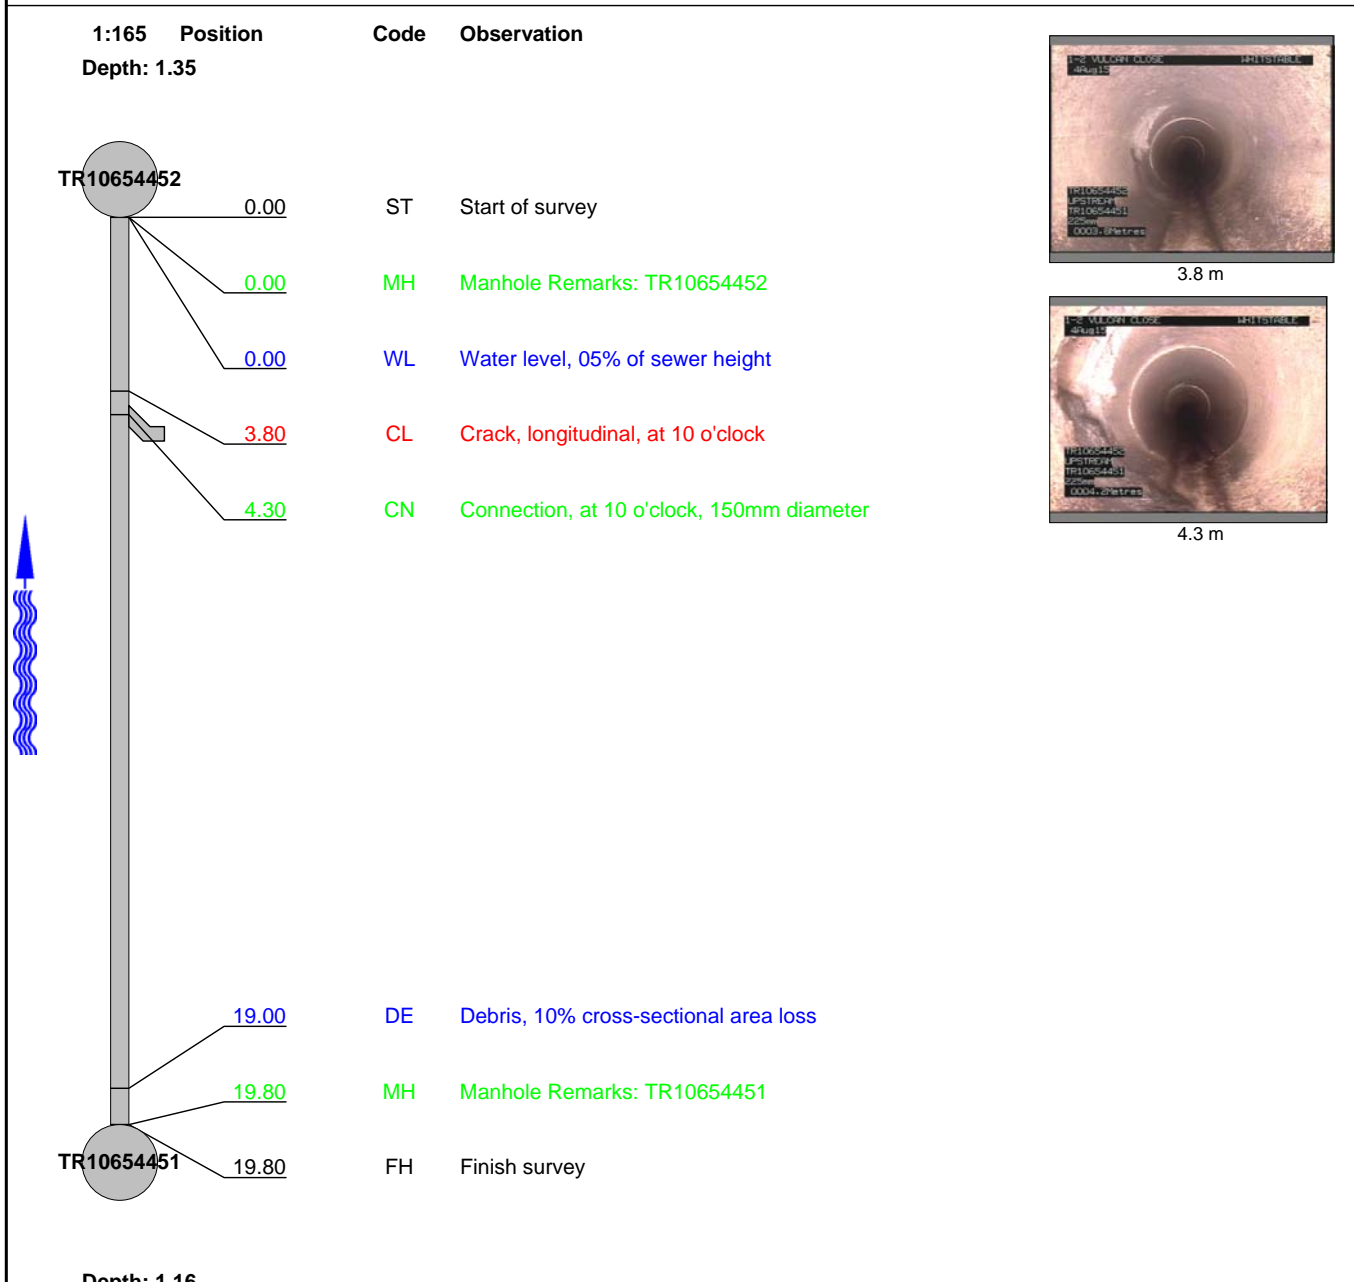
Structural Defects					Constructional Features				
Service Defects					Miscellaneous Features				
STR no def	STR peak	STR mean	STR total	STR grade	SER no def	SER peak	SER mean	SER total	SER grade
1	10	0.51	10	2	1	2	0.1	2	3
