Vulcan Close, Whitstable, Kent
Phase 1 (Plots 1 to 5)

Drainage Verification Report

30 April 2024
Project Reference: 65203468
Document Reference: 66200272-SWE-XX-XX-T-C-0001-P01- Vulcan
Drainage Verification
Revision: P01
Prepared For: Aspire Designer Homes

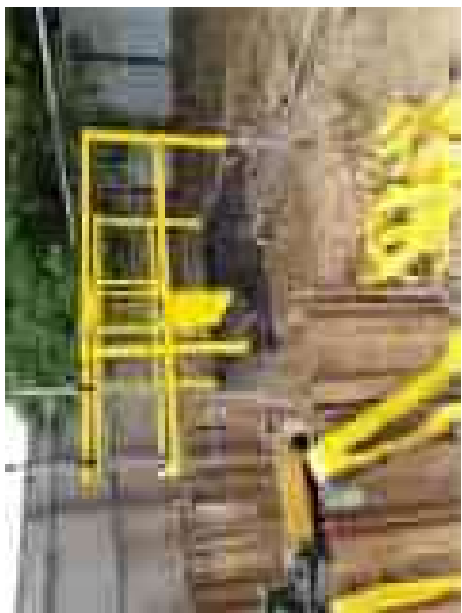
Photo 25

**Product removed from site to be returned / disposed of at TT
works for appropriate repair/ disposed of in applicable waste
stream**

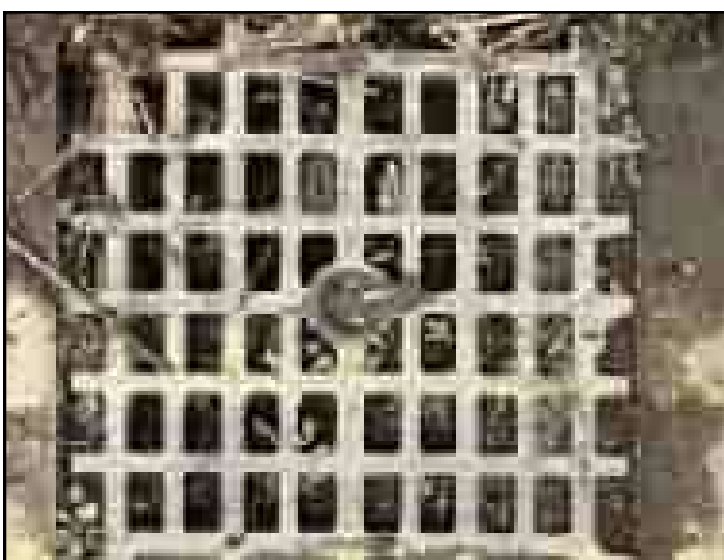
GULLY 6.
DEBRIS FILLED

Sweco recommend the Phase 1 drainage is jetted clean prior to first occupation, and on completion of the Phase 2 (upstream) elements.

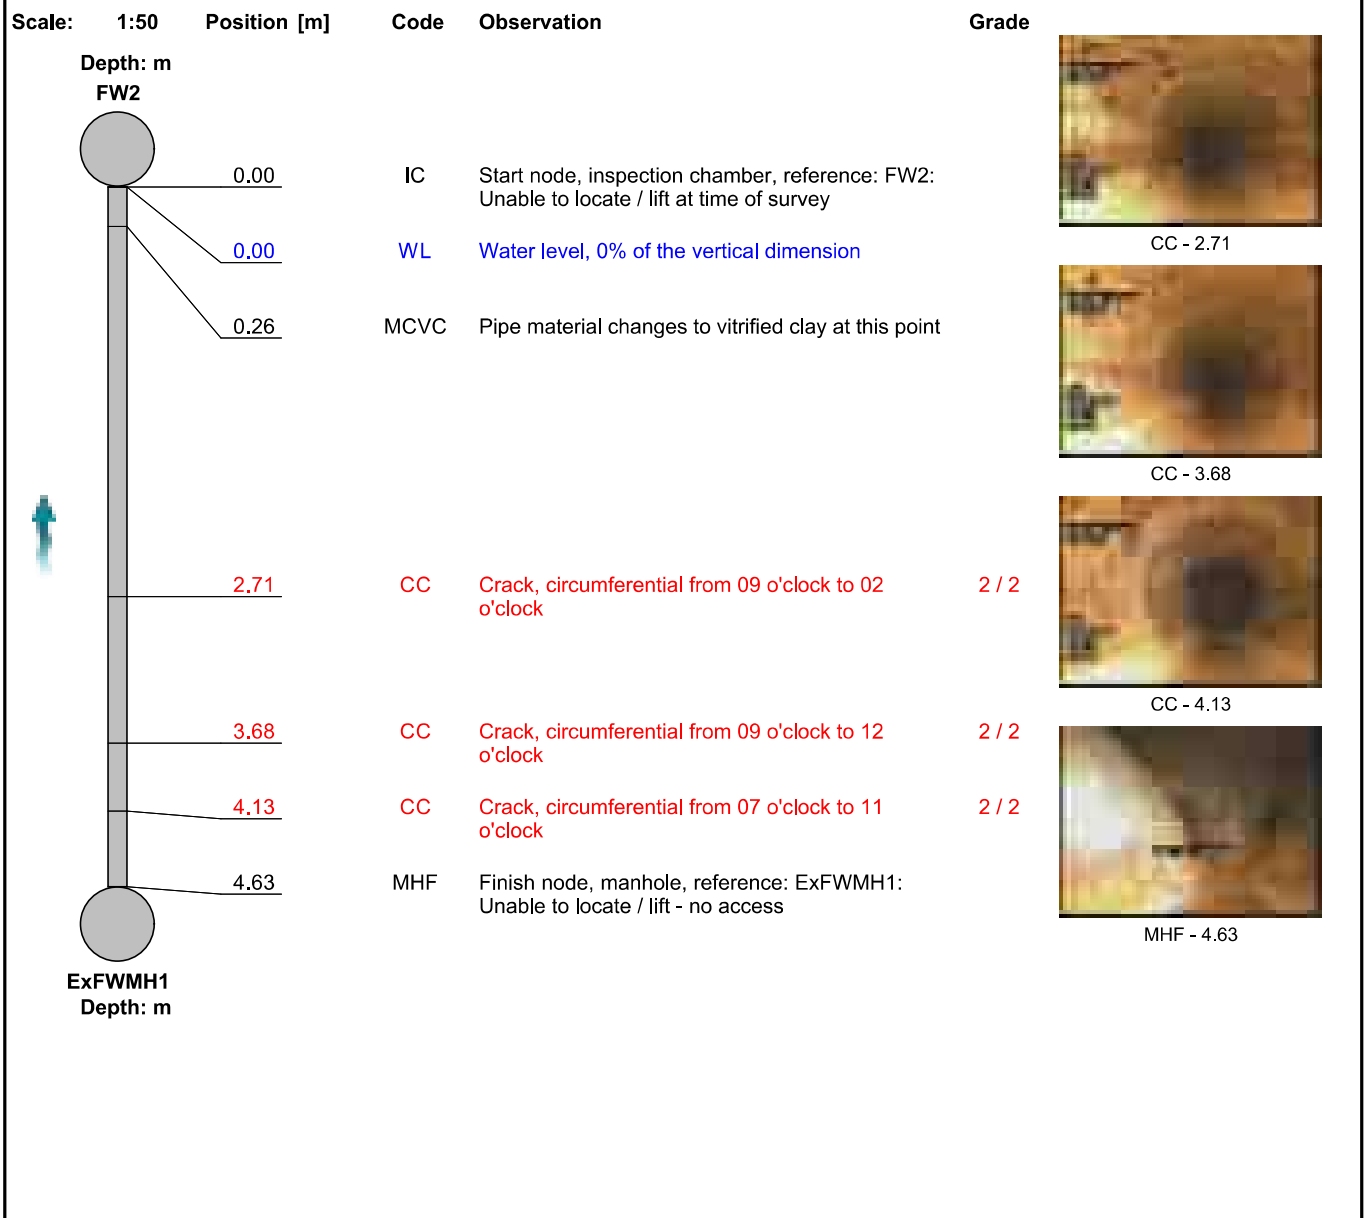
1, 00:00:33, 2.71 m
Crack, circumferential from 09 o'clock to 02 o'clock

2, 00:00:52, 3.68 m
Crack, circumferential from 09 o'clock to 12 o'clock

3, 00:01:09, 4.13 m
Crack, circumferential from 07 o'clock to 11 o'clock

Section number	Upstream manhole	Flow direction	Downstream manhole	Recommendations
1	FW2	Upstream	FW1	
2	ExFWMH1	Upstream	FW2	Repair defect(s) by lining
3	FW1	Downstream	FW3	
4	SW2	Upstream	SW1	Repair defect(s) by lining
5	ExSWMH1	Upstream	SW2	
6	SW1	Downstream	SW3	
7	FW3	Downstream	FW4	
8	SW3	Downstream	SW4	
9	FW4	Downstream	FW5	
10	SW4	Downstream	SW5	
11	RE1	Upstream	SW5	Clean by van pack jetting unit and resurvey
12	SW5	Downstream	SW6	
13	FW5	Downstream	FW6	Clean by van pack jetting unit and resurvey
14	SW6-A	Upstream	SW6	
15	SW6	Downstream	SW7	
16	FW6	Downstream	FW7	
17	RE2	Upstream	SW8	
18	SW8	Downstream	RUN X	
19	FW8	Downstream	FW7	Clean by van pack jetting unit and resurvey
20	FW7	Downstream	P.S.1	
21	SW7	Downstream	SW9	Clean by HGV JetVac unit and resurvey
22	SW10	Upstream	SW9	Clean by HGV JetVac unit and resurvey
23	SW9	Downstream	P.S.2	Clean by HGV JetVac unit and resurvey
24	RE3	Upstream	SW11	
25	SW11-B	Upstream	SW11

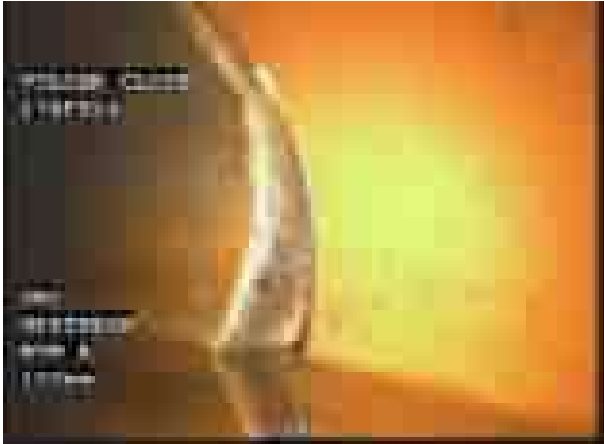
1, 00:00:20, 0.28 m
Joint displaced, medium

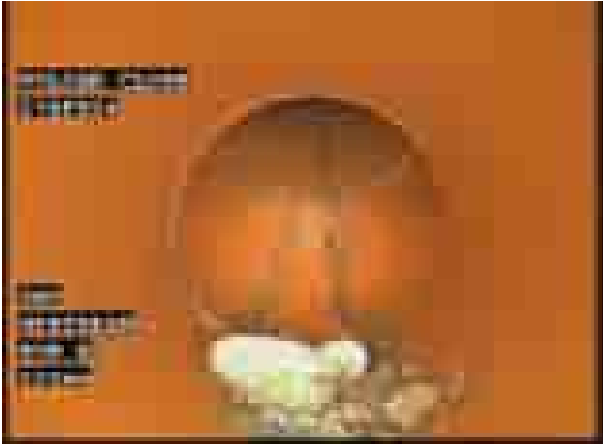
1, 00:01:11, 8.41 m
Settled deposits, hard or compacted, 5% cross-sectional area loss

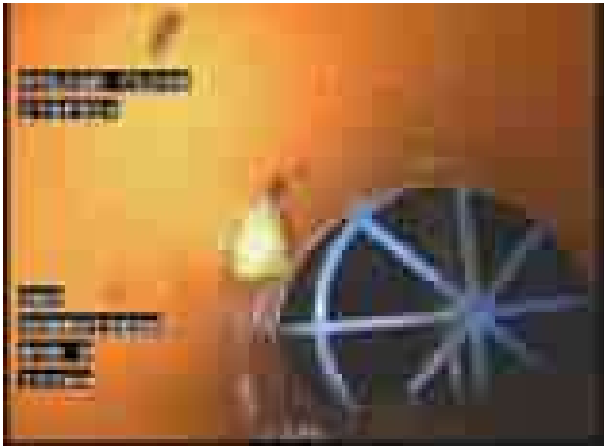
Item No.	Inspection Direction	PLR	Client's Job Ref	Contractor's Job Ref
18	Downstream	SW8X	TV240428

1, 00:00:14, 0.53 m
Settled deposits, hard or compacted, 10% cross-sectional area loss

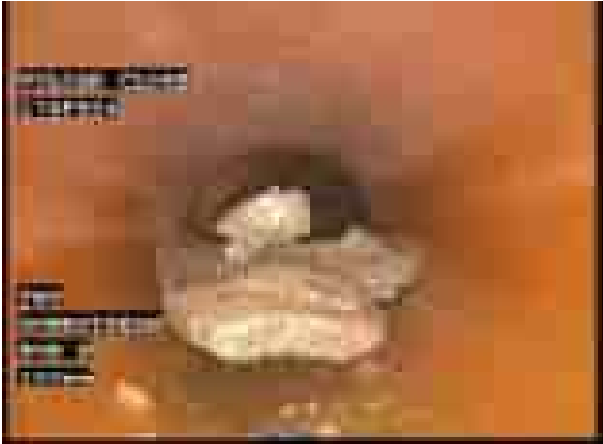
Item No.	Inspection Direction	PLR	Client's Job Ref	Contractor's Job Ref
19	Downstream	FW8X	TV240428

1, 00:00:33, 3.43 m
Settled deposits, hard or compacted, 50% cross-sectional area loss

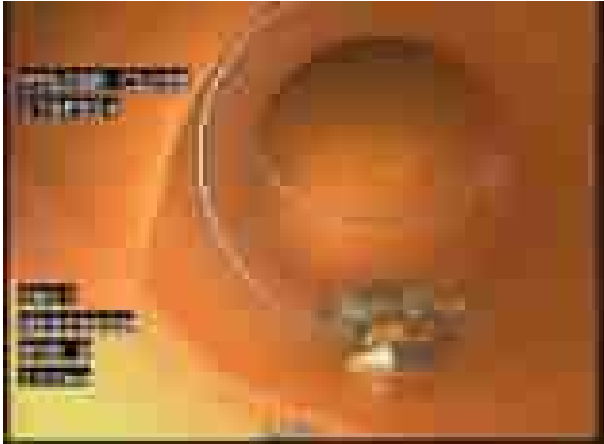
Item No.	Inspection Direction	PLR	Client's Job Ref	Contractor's Job Ref
24	Upstream	RE3X	TV240428

1, 00:00:37, 7.14 m
Settled deposits, fine, 5% cross-sectional area loss

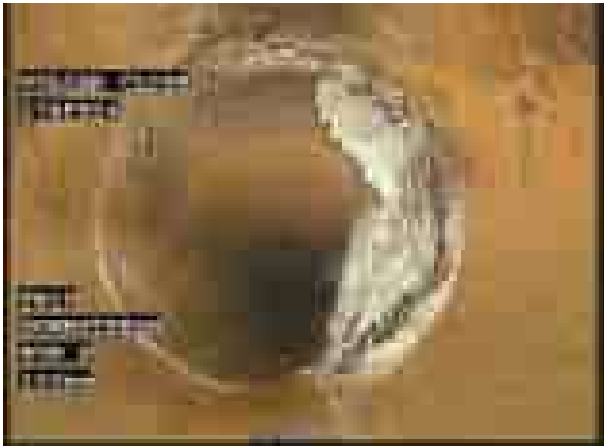
Item No.	Inspection Direction	PLR	Client's Job Ref	Contractor's Job Ref
28	Downstream	FW10X	TV240428

1, 00:00:16, 2.55 m
Roots, mass at joint, 10% cross-sectional area loss
